Avila Beach

Sea-Level Rise Vulnerability Assessment

PORT SAN LUIS HARBOR DISTRICT AUGUST 2020

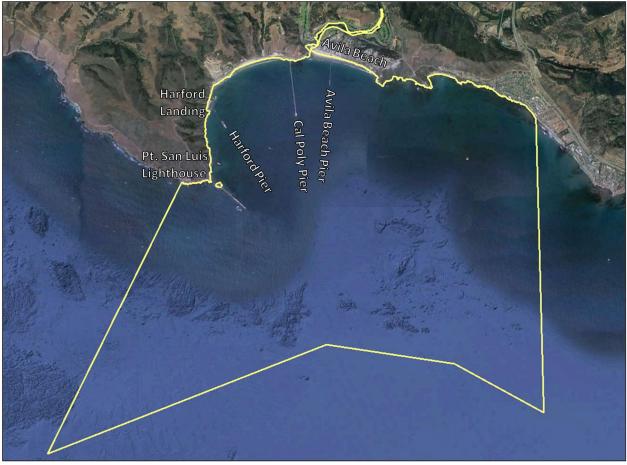
Figure 1-1: Port San Luis State Grant Area Boundary.

The vulnerability assessment covers the State Grant Area delineated on the California State Lands Commission (CSLC) grant plat, which includes the sovereign tidelands and submerged lands of Port San Luis. The boundary of the State Grant Area is indicated by the yellow outline in Figure 1-1.

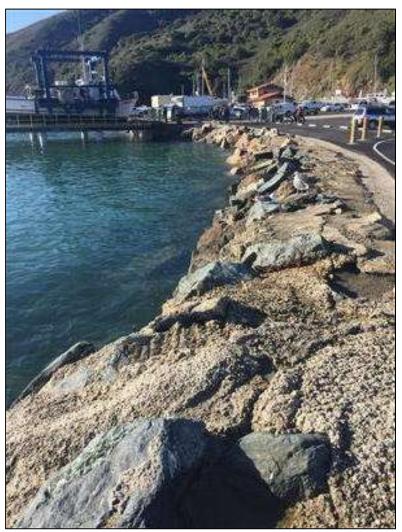
Figure 2-4: King tide at Harford Landing, January 11, 2020.

- <u>Tides</u> occur regularly with about two high tides and two low tides each day. The highest tides (spring tides) occur twice a month during the full moon and the new moon. Around December and January when a new or full moon occurs at the same time as the sun is at its closest to the earth, the tides run higher. These higher perigean spring tides are commonly known as king tides. See Figure 2-4 for a photo of a king tide at Harford Landing.

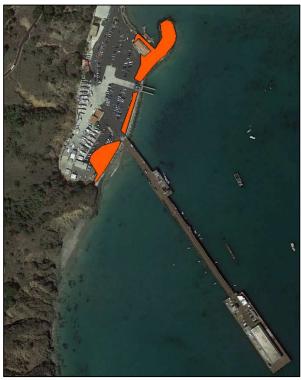
Figure 2-5: Areas exposed to wave overtopping.

The waterfront edge at Harford Landing is exposed to wave overtopping annually during winter storms. The orange shading in Figure 2-5 indicates the areas that are subject to wave overtopping. Figure 2-6 shows an example of conditions during a significant wave overtopping event.

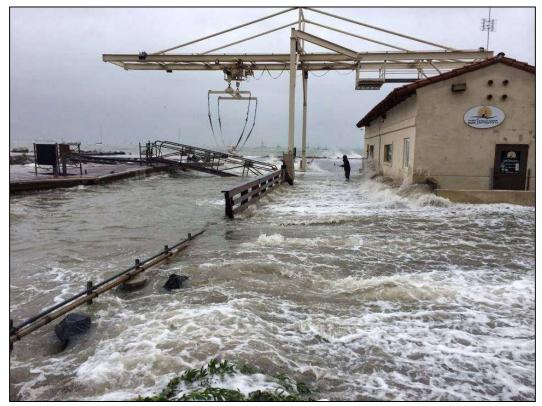
Figure 2-6: Wave overtopping at the Port San Luis Boat Lift (Olde Port Boat Launch).

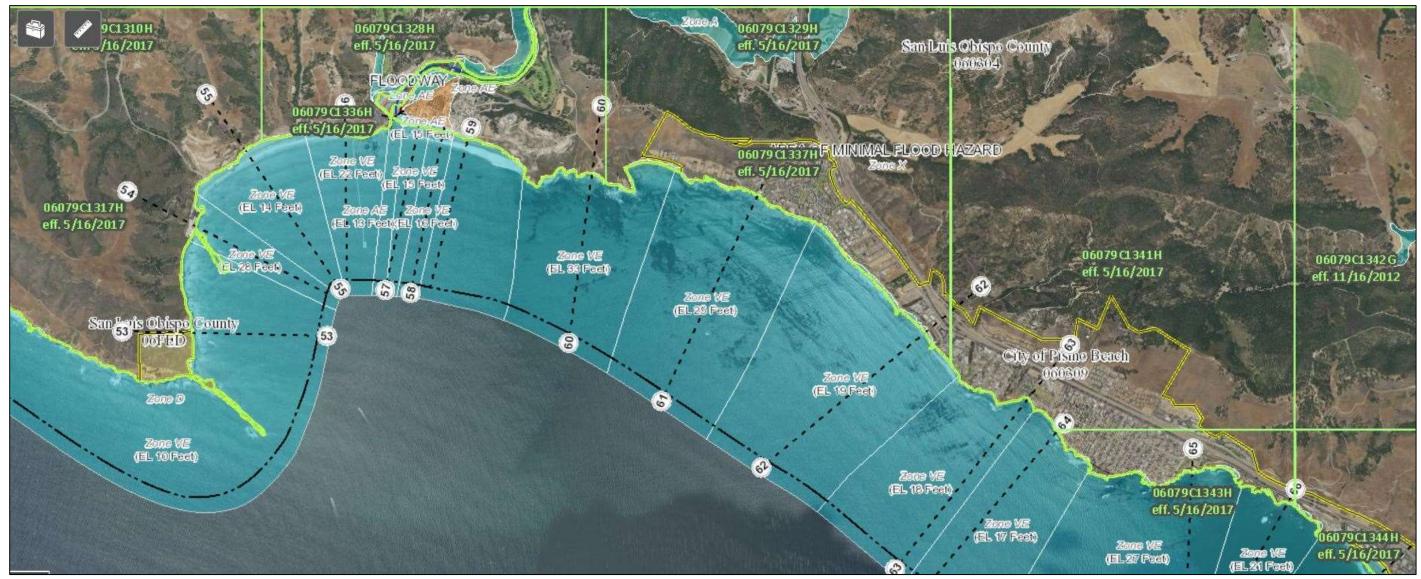
Plate 2: FEMA FIRM for Avila Beach.

- <u>1% Annual Chance Storm.</u> Representative of an extreme storm event with an average recurrence interval of 100 years. This scenario reflects the FEMA 1% annual chance event. The extreme water level associated with this scenario accounts for storm surge, high tide, El Niño effects, and wave action. The FEMA FIRM for Avila Beach is shown on Plate 2.

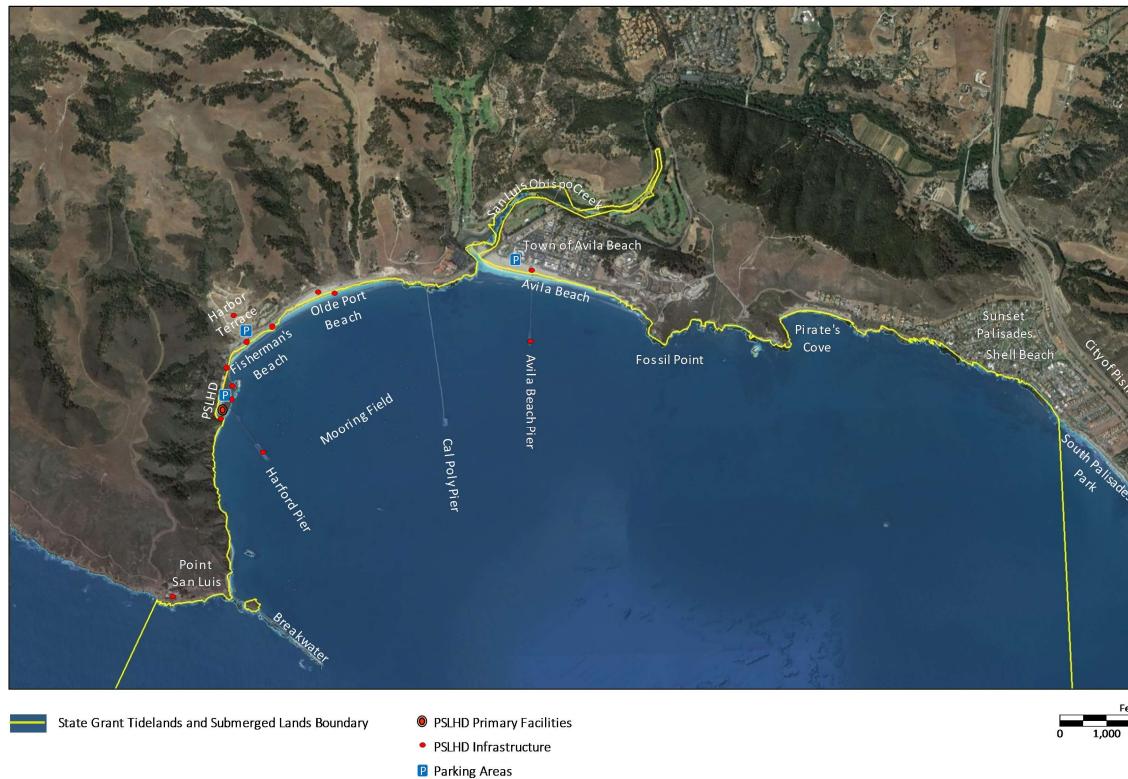
Plate 5: Flood Hazard Zones associated with Daily Inundation due to Rising Tides for Existing Conditions.

A map of the present day MHW shoreline location is shown on Plate 5. Projected future shoreline locations are defined as areas below the MHW line that would be subject to daily inundation as a result of sea-level rise. Projections for sea-level rise by 2030, 2050, and 2100 are shown on Plate 6, Plate 7, and Plate 8. For details of flood risks at Harford Landing, along Avila Beach Dr., and at Avila Beach refer to the following appendices:

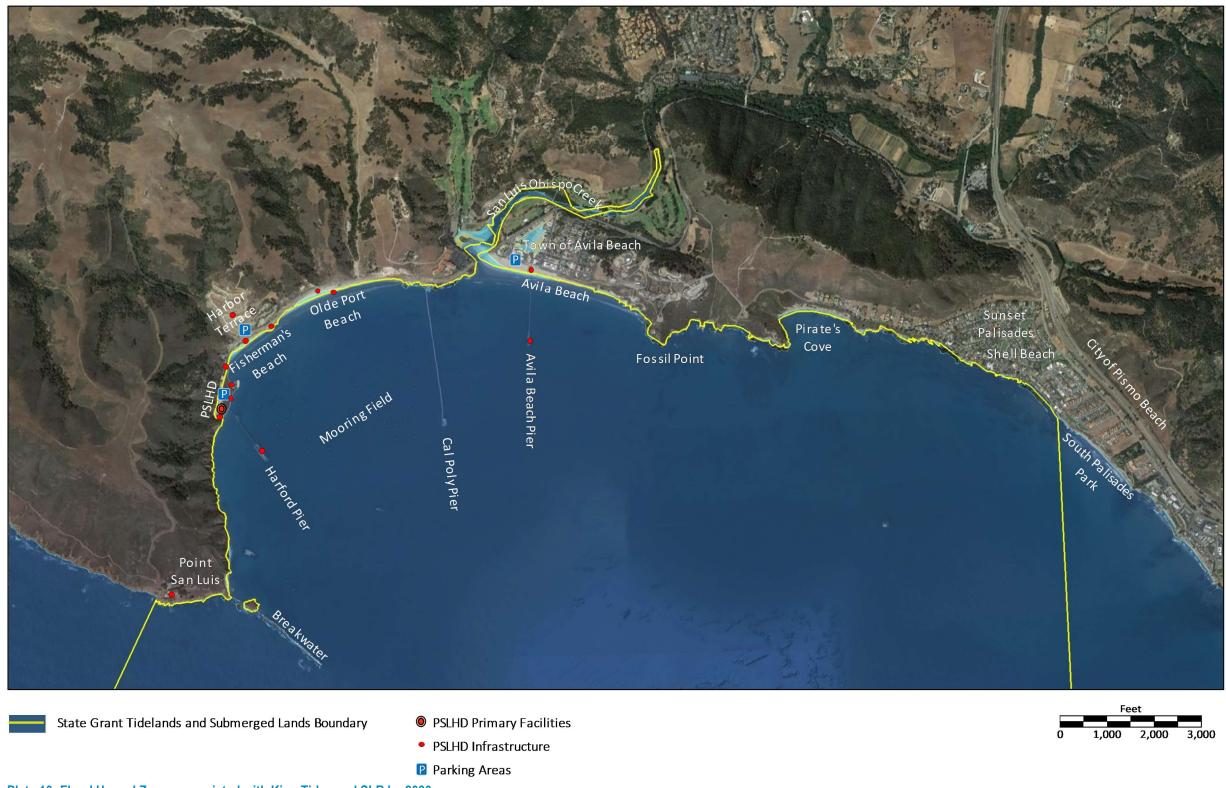
Plate 10: Flood Hazard Zones associated with King Tides and SLR by 2030.

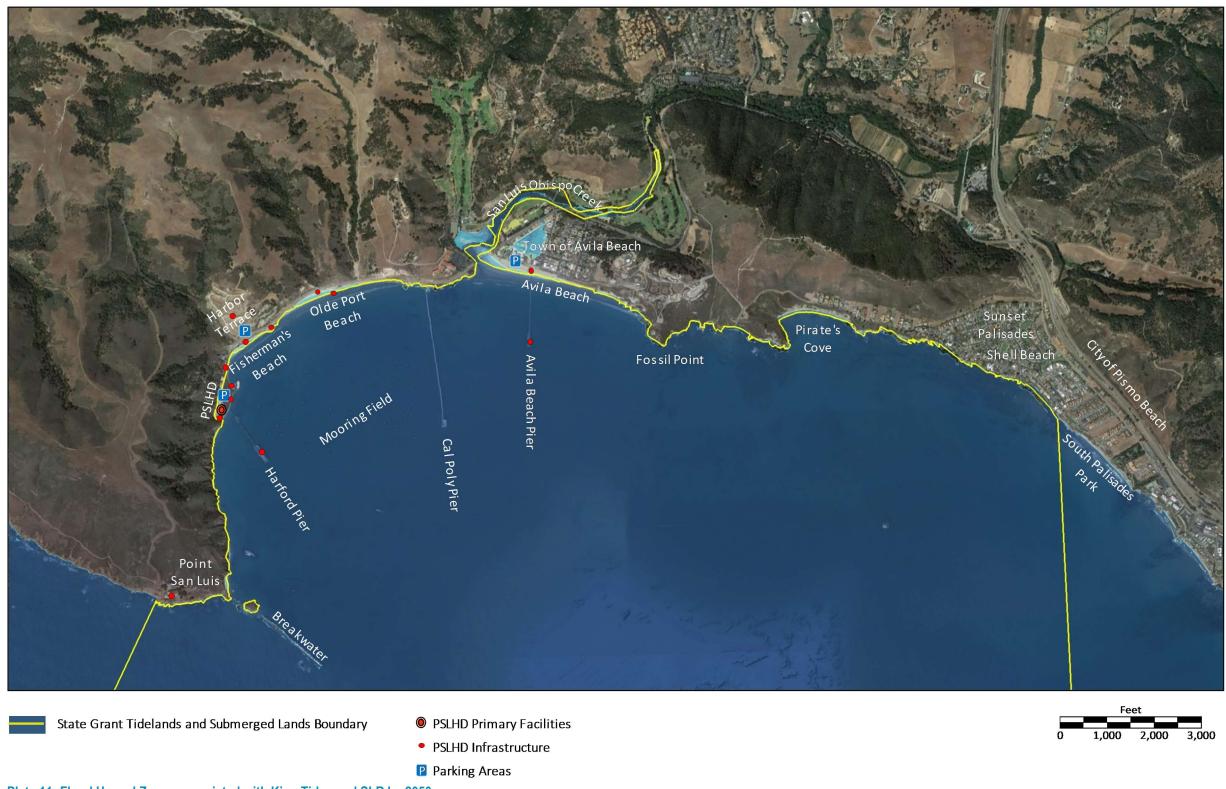
Plate 11: Flood Hazard Zones associated with King Tides and SLR by 2050.

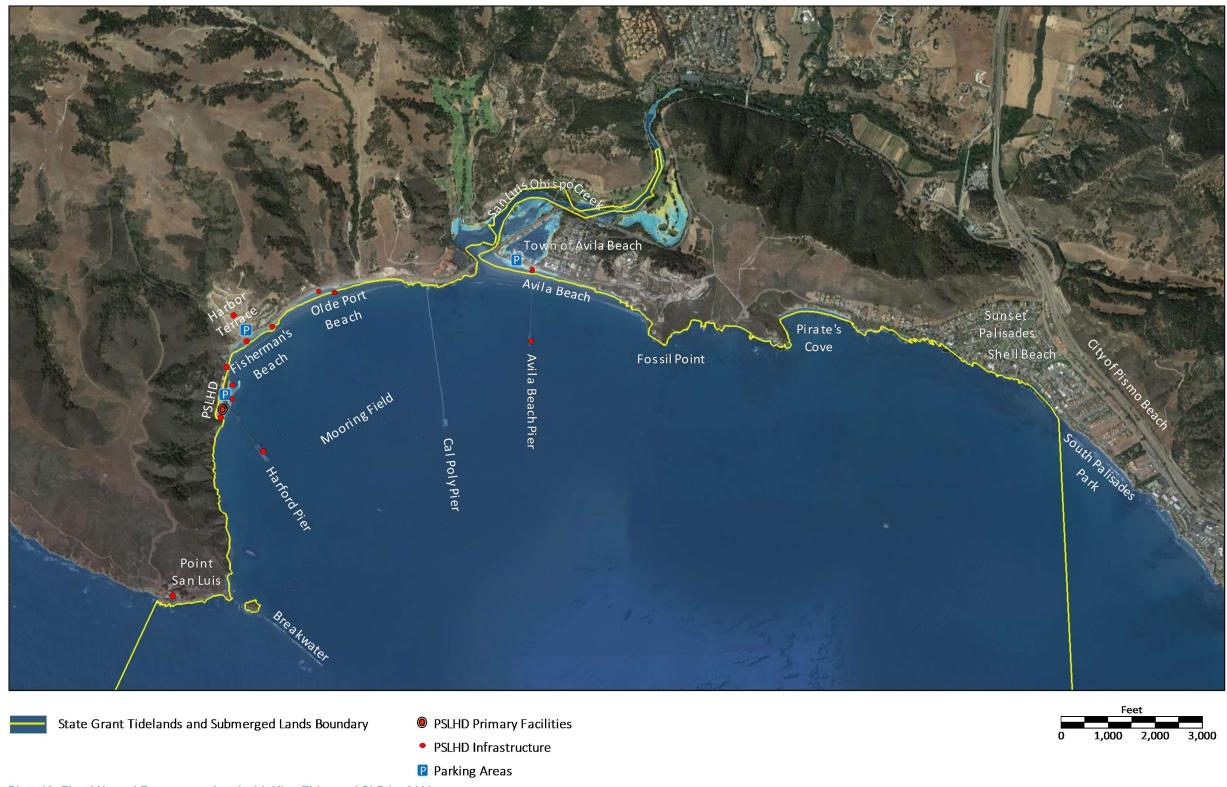
Plate 12: Flood Hazard Zones associated with King Tides and SLR by 2100.

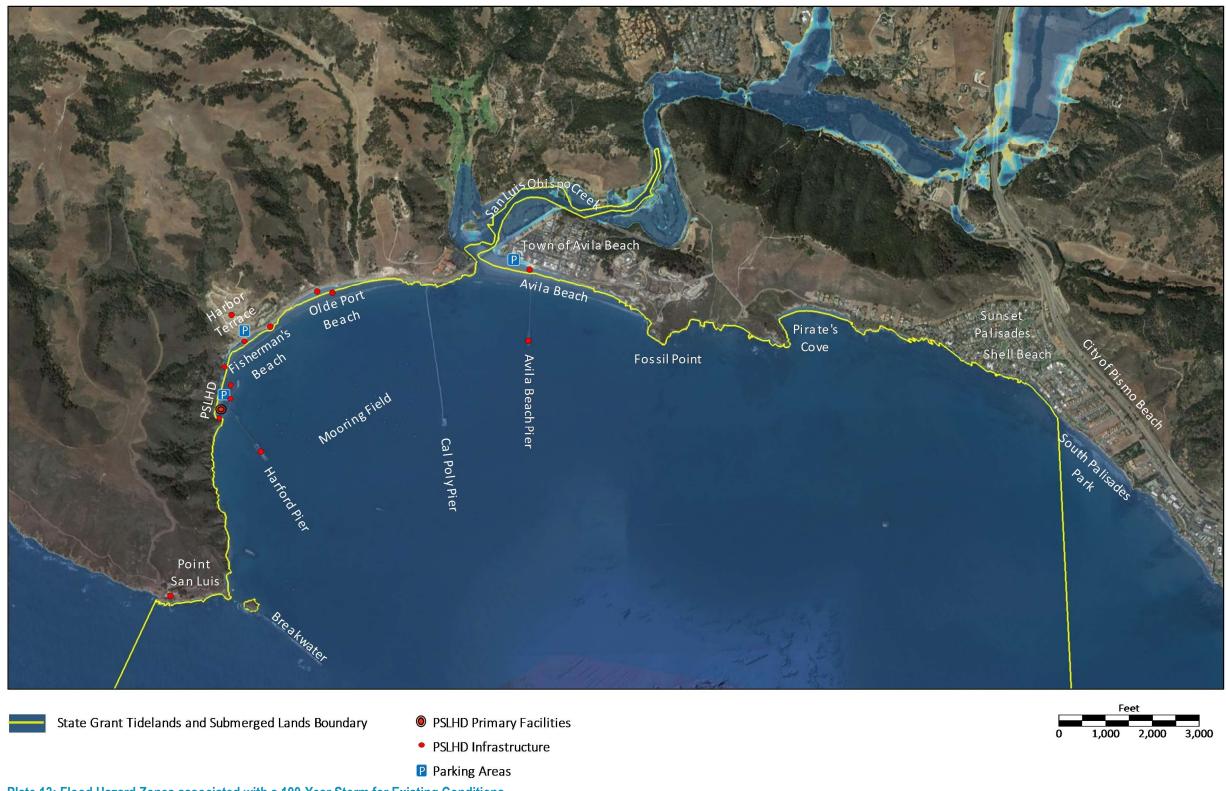
Plate 13: Flood Hazard Zones associated with a 100-Year Storm for Existing Conditions.

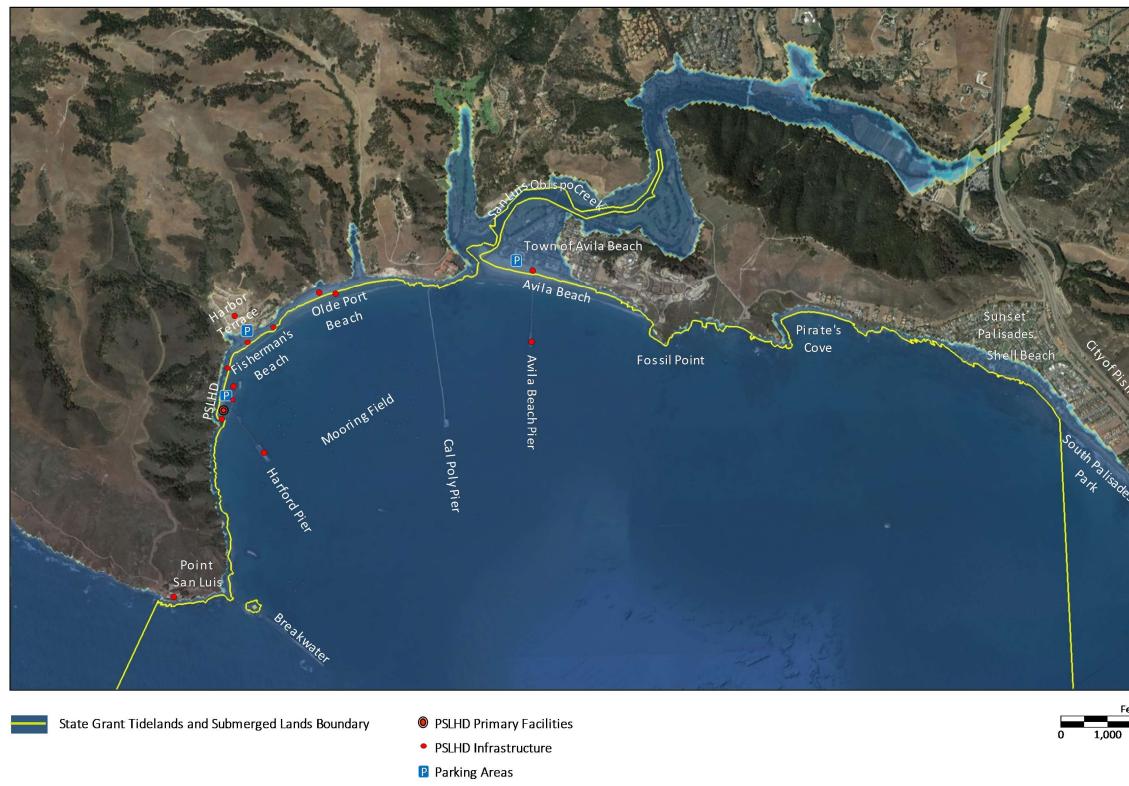
Plate 21: Inundation associated with Tsunami Hazards for Existing Conditions.

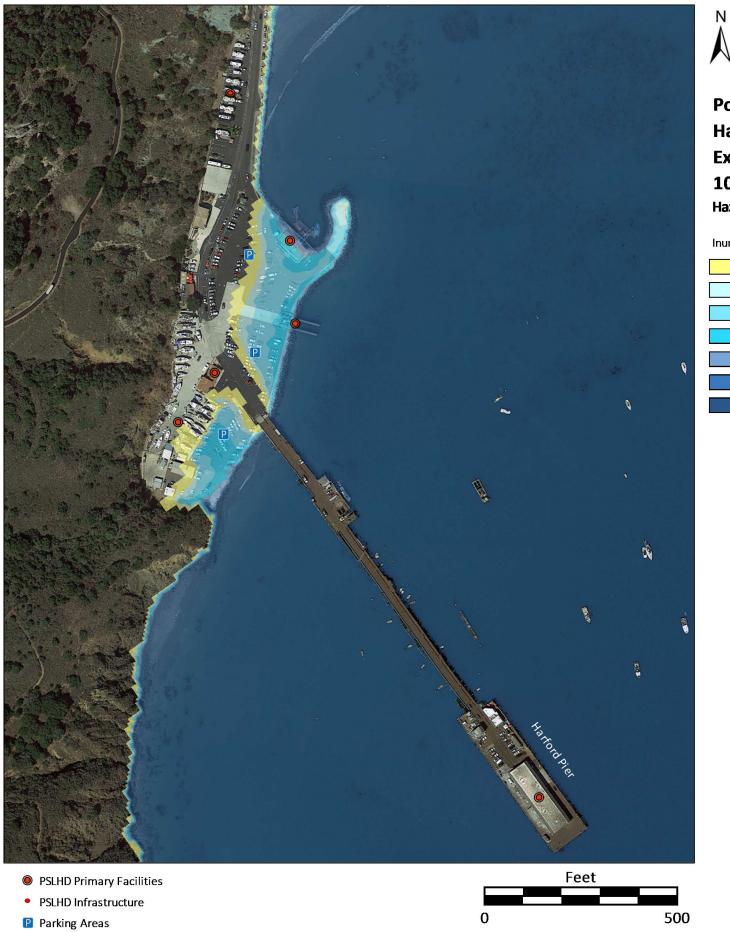
Plate 10: Flood Hazard Zones associated with a 100-Year Storm for Existing Conditions.

Port San Luis Harford Landing Existing Conditions 100-Year Storm Hazard Zones

- Harford Landing, Appendix B, Plate 10 to 13 (existing conditions, 2030, 2050, and 2100).
- Avila Beach Drive, Appendix C, Plate 10 to 13.
- Avila Beach, Appendix D, Plate 10 to 13.

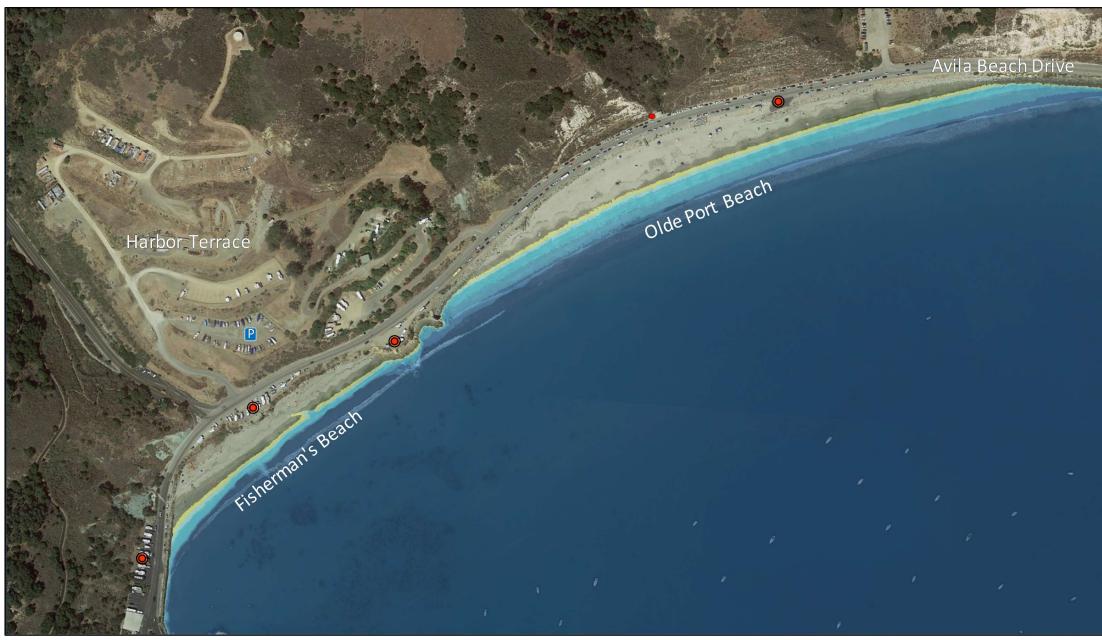
Plate 2: Flood Hazard Zones associated with Daily Inundation due to Rising Tides for Existing Conditions.

Avila Beach Drive Existing Conditions Daily Inundation Hazard Zones

- Harford Landing, Appendix B, Plate 2 to 5 (existing conditions, 2030, 2050, and 2100).
- Avila Beach Drive, Appendix C, Plate 2 to 5.
- Avila Beach, Appendix D, Plate 2 to 5.

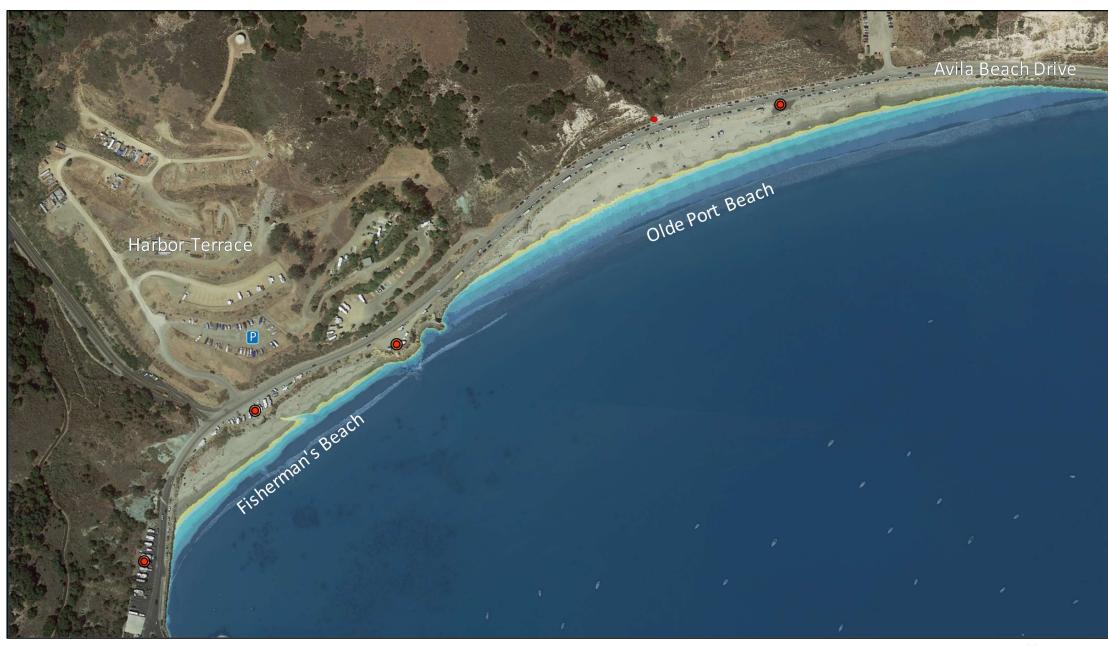
Plate 3: Flood Hazard Zones associated with Daily Inundation due to Rising Tides and SLR by 2030.

Avila Beach Drive 2030 Daily Inundation Hazard Zones

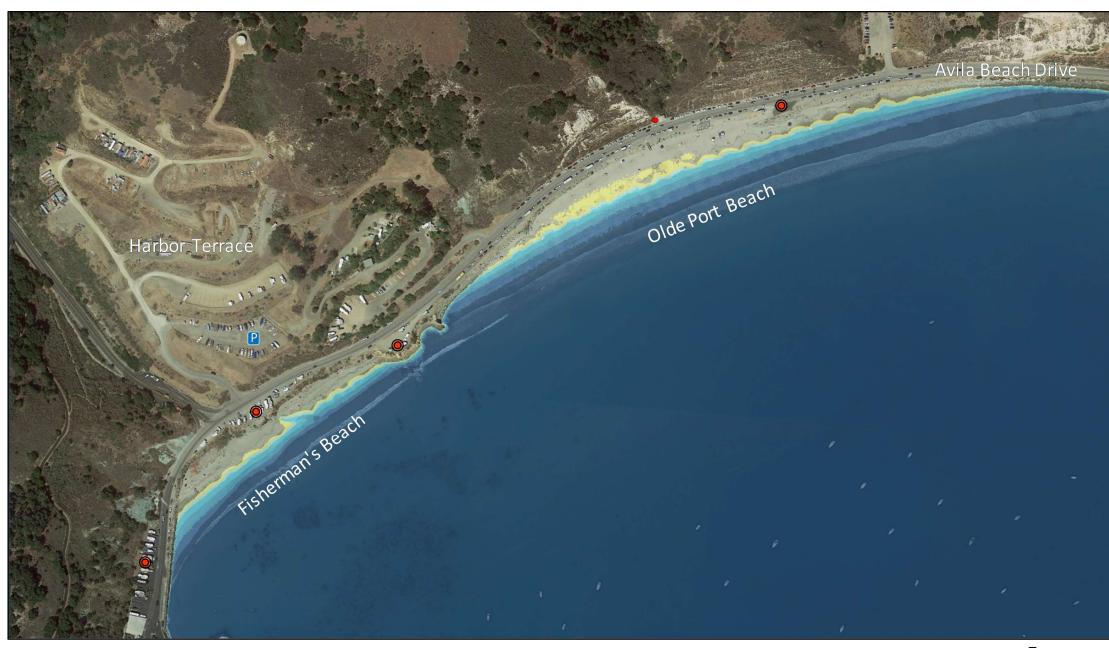
Plate 4: Flood Hazard Zones associated with Daily Inundation due to Rising Tides and SLR by 2050.

Avila Beach Drive 2050 Daily Inundation Hazard Zones

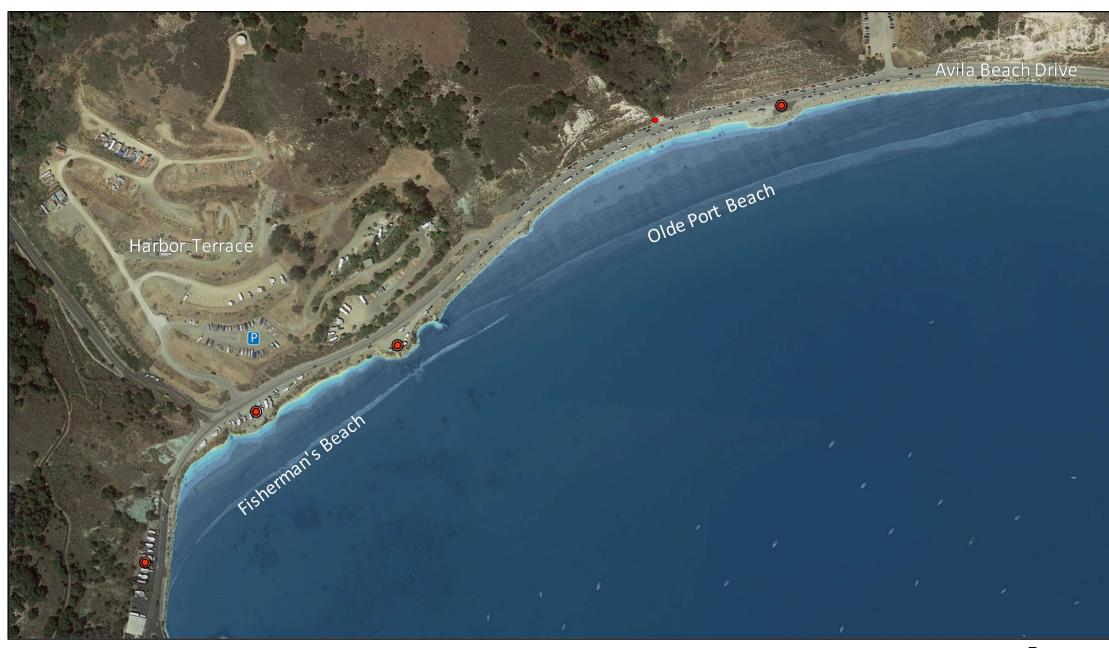
Plate 5: Flood Hazard Zones associated with Daily Inundation due to Rising Tides and SLR by 2100.

Avila Beach Drive 2100 Daily Inundation Hazard Zones

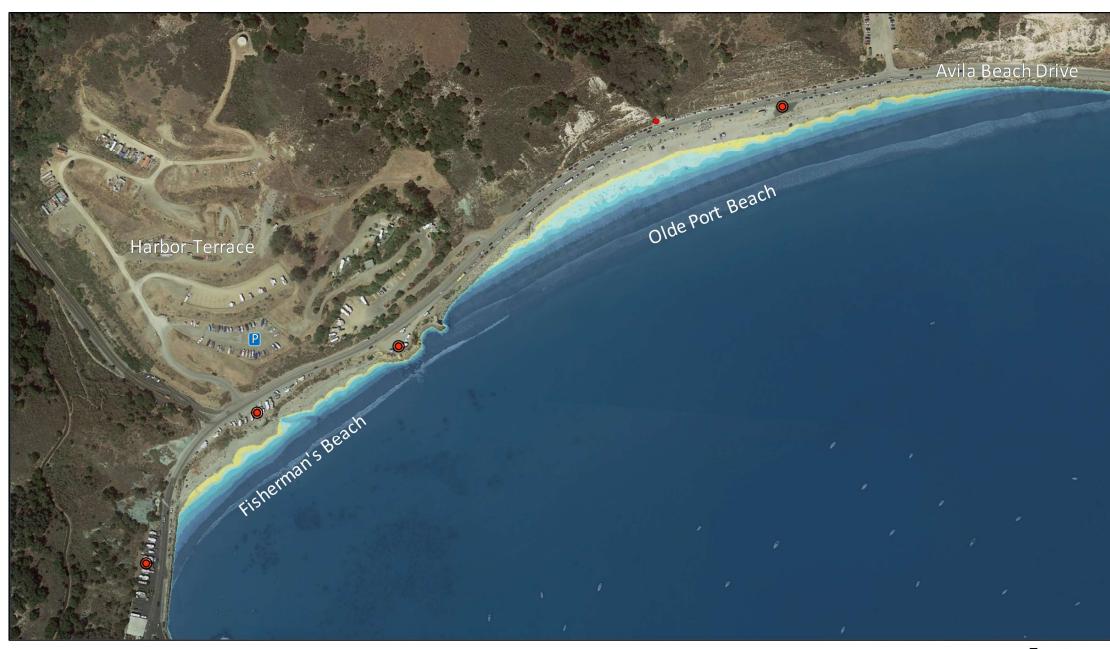
Plate 6: Flood Hazard Zones associated with King Tides for Existing Conditions.

Avila Beach Drive Existing Conditions King Tides Hazard Zones

- Harford Landing, Appendix B, Plate 6 to 9 (existing conditions, 2030, 2050, and 2100).
- Avila Beach Drive, Appendix C, Plate 6 to 9.
- Avila Beach, Appendix D, Plate 6 to 9.

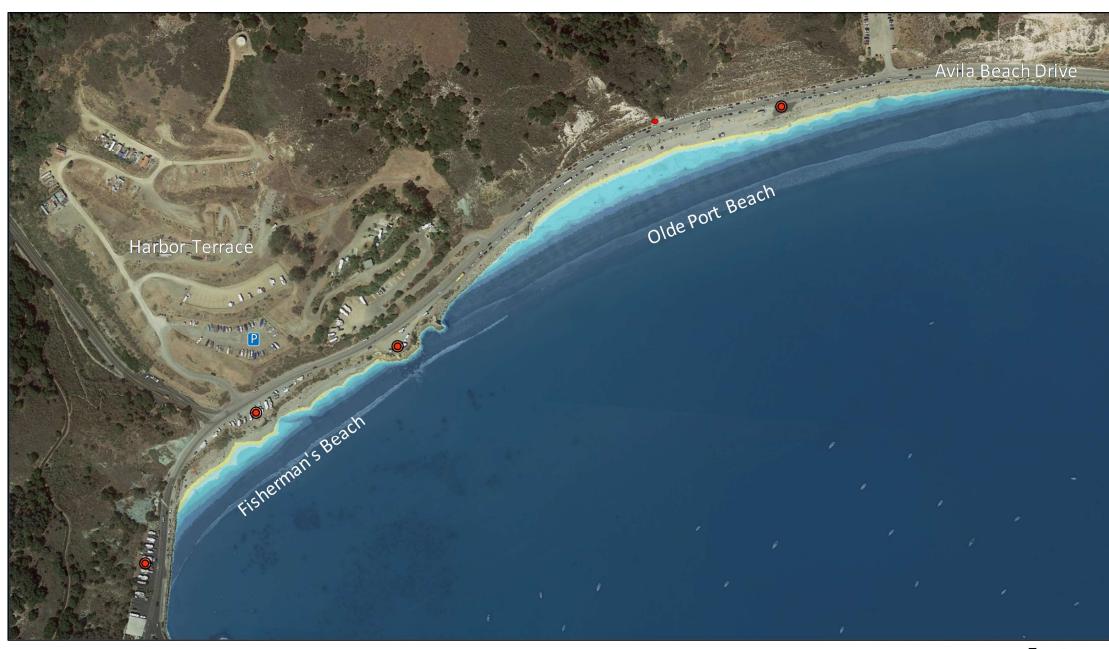
Plate 7: Flood Hazard Zones associated with King Tides and SLR by 2030.

Avila Beach Drive 2030 King Tides Hazard Zones

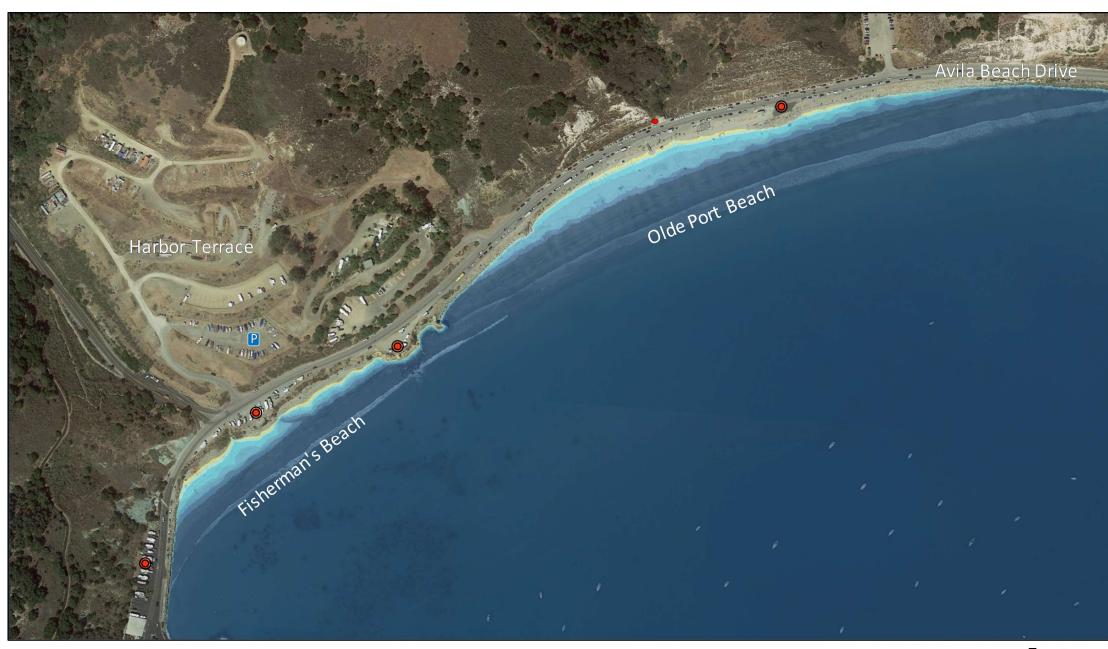
Plate 8: Flood Hazard Zones associated with King Tides and SLR by 2050.

Avila Beach Drive 2050 King Tides Hazard Zones

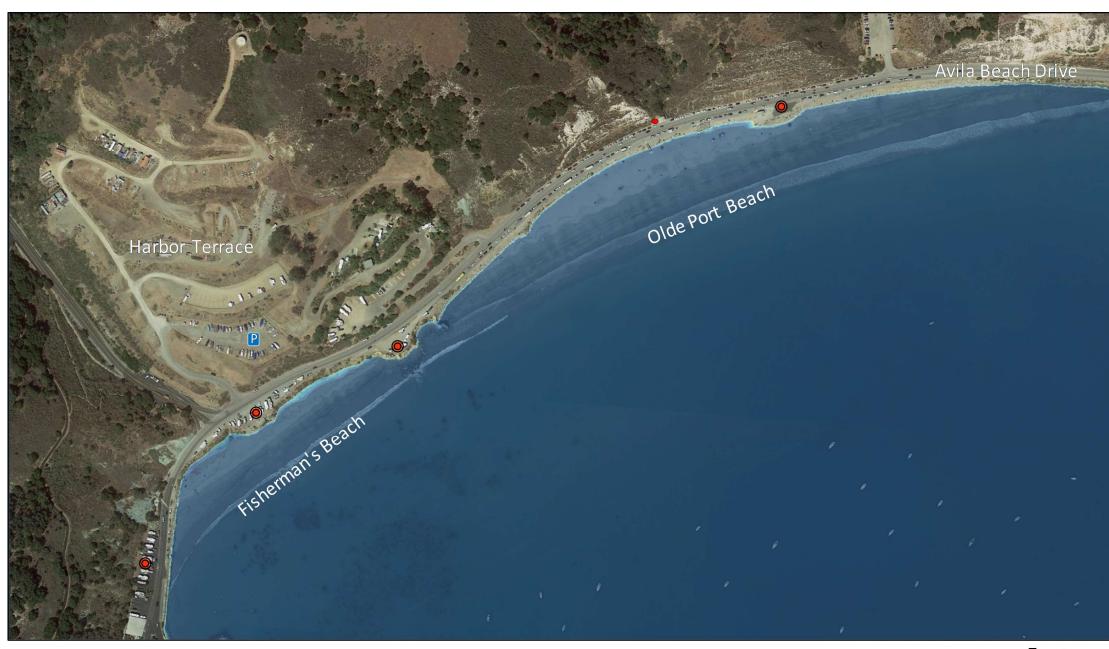
Plate 9: Flood Hazard Zones associated with King Tides and SLR by 2100.

Avila Beach Drive 2100 King Tides Hazard Zones

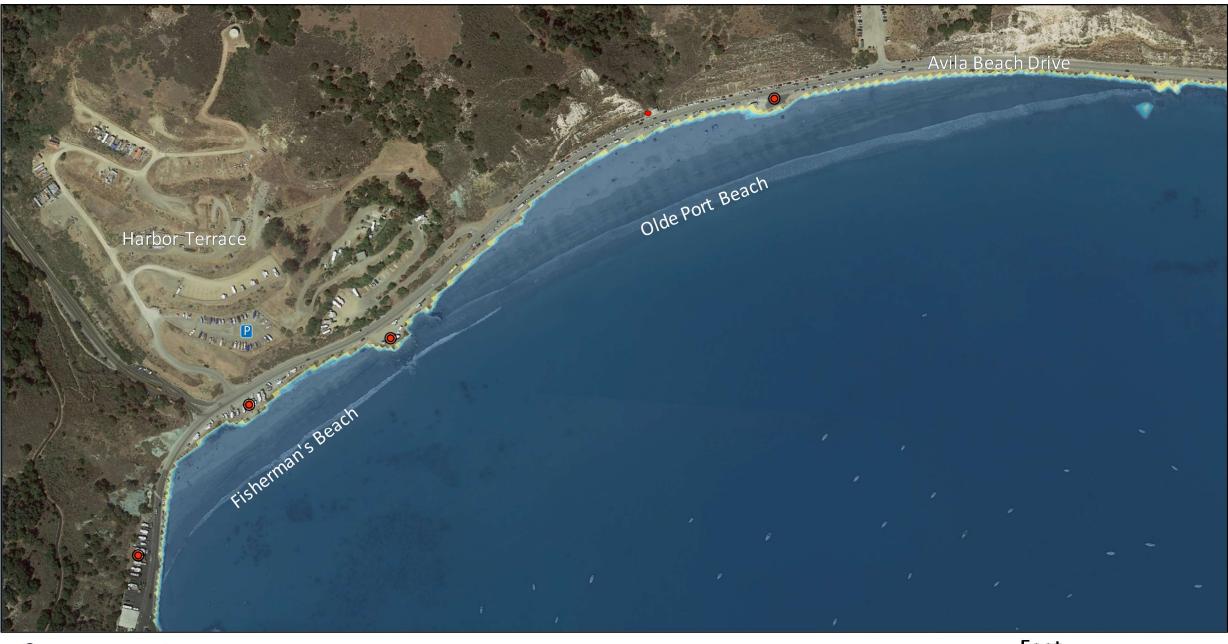
Plate 10: Flood Hazard Zones associated with a 100-Year Storm for Existing Conditions.

Avila Beach Drive Existing Conditions 100-Year Storm Hazard Zones

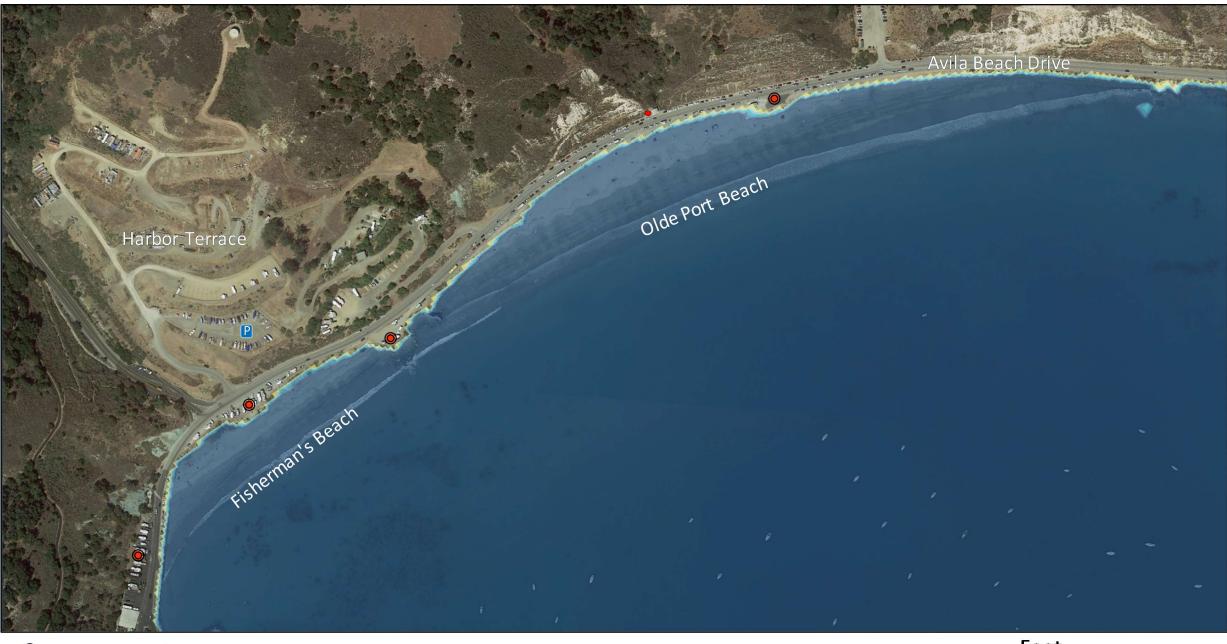
Plate 11: Flood Hazard Zones associated with a 100-Year Storm and SLR by 2030.

Avila Beach Drive 2030 100-Year Storm Hazard Zones

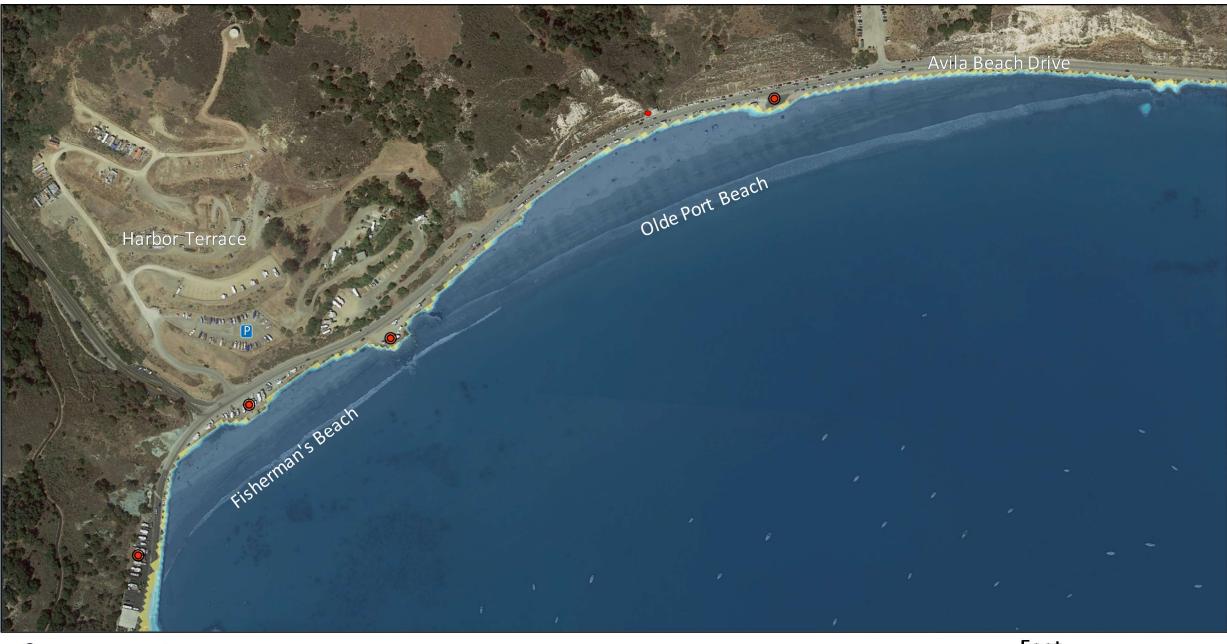
Plate 12: Flood Hazard Zones associated with a 100-Year Storm and SLR by 2050.

Avila Beach Drive 2050 100-Year Storm Hazard Zones

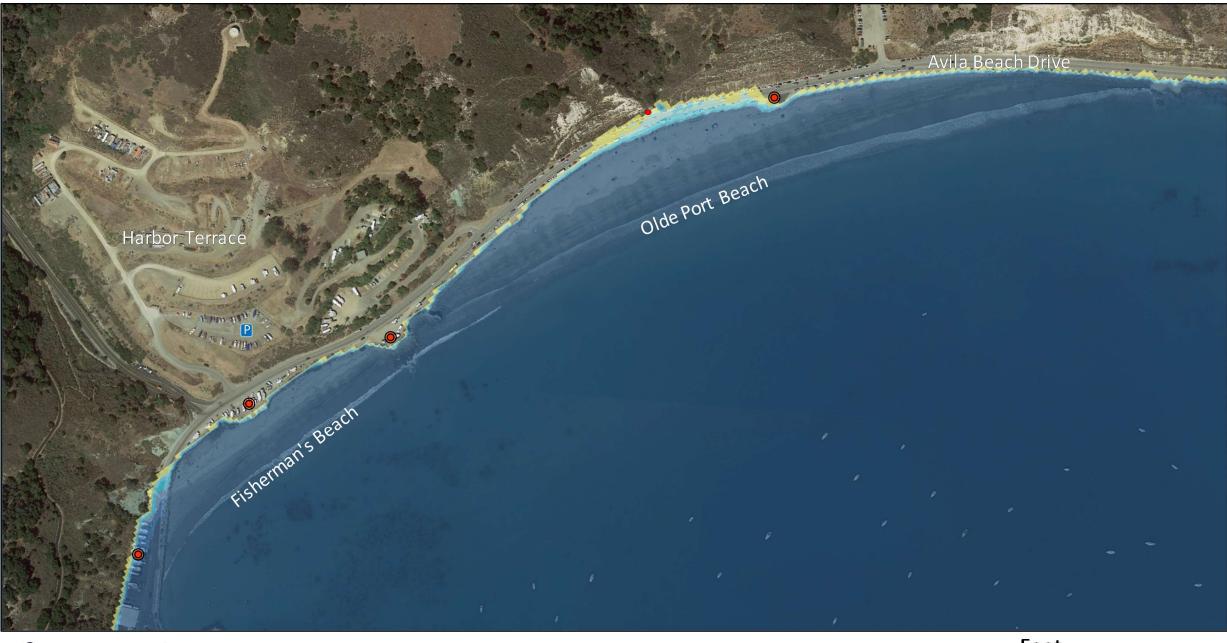
Plate 13: Flood Hazard Zones associated with a 100-Year Storm and SLR by 2100.

Avila Beach Drive 2100 100-Year Storm Hazard Zones

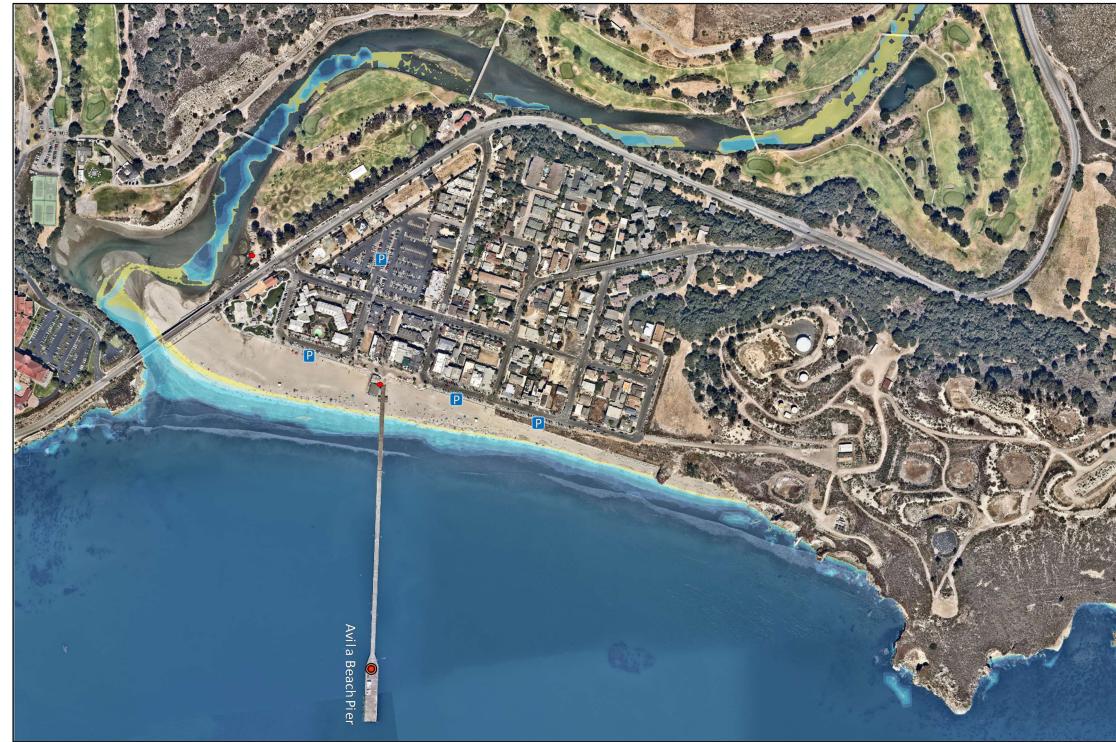
Plate 2: Flood Hazard Zones associated with Daily Inundation due to Rising Tides for Existing Conditions.

Avila Beach Existing Conditions Daily Inundation Hazard Zones

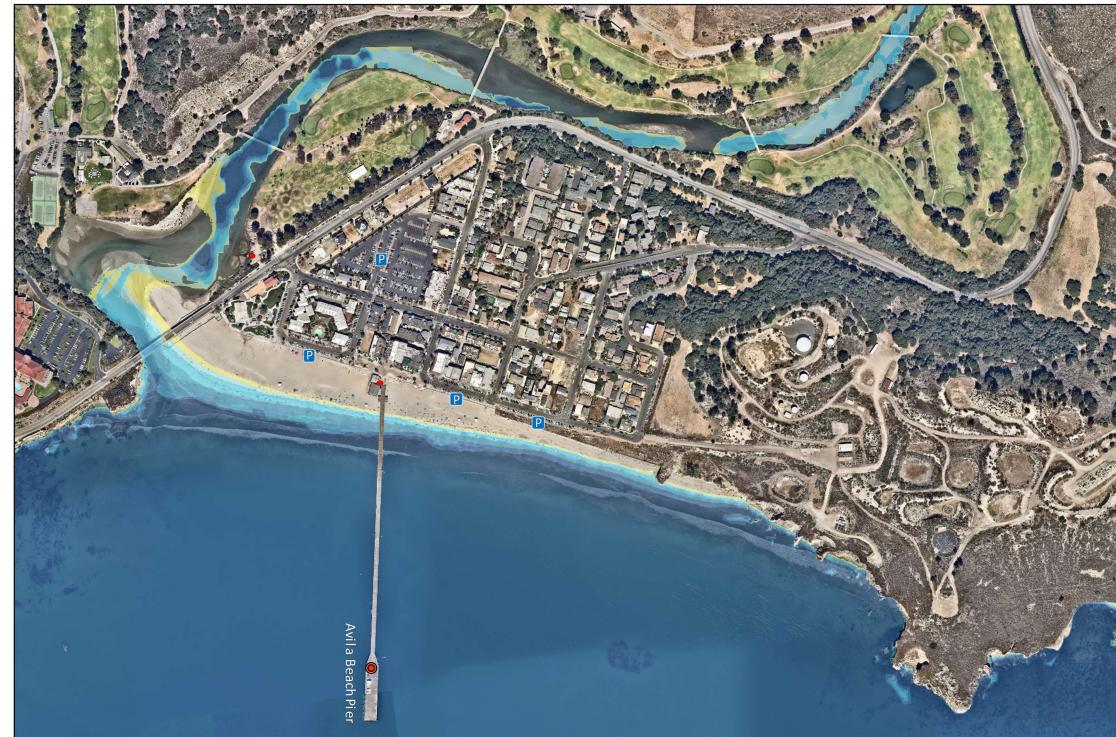
Plate 3: Flood Hazard Zones associated with Daily Inundation due to Rising Tides and SLR by 2030.

Avila Beach 2030 Daily Inundation Hazard Zones

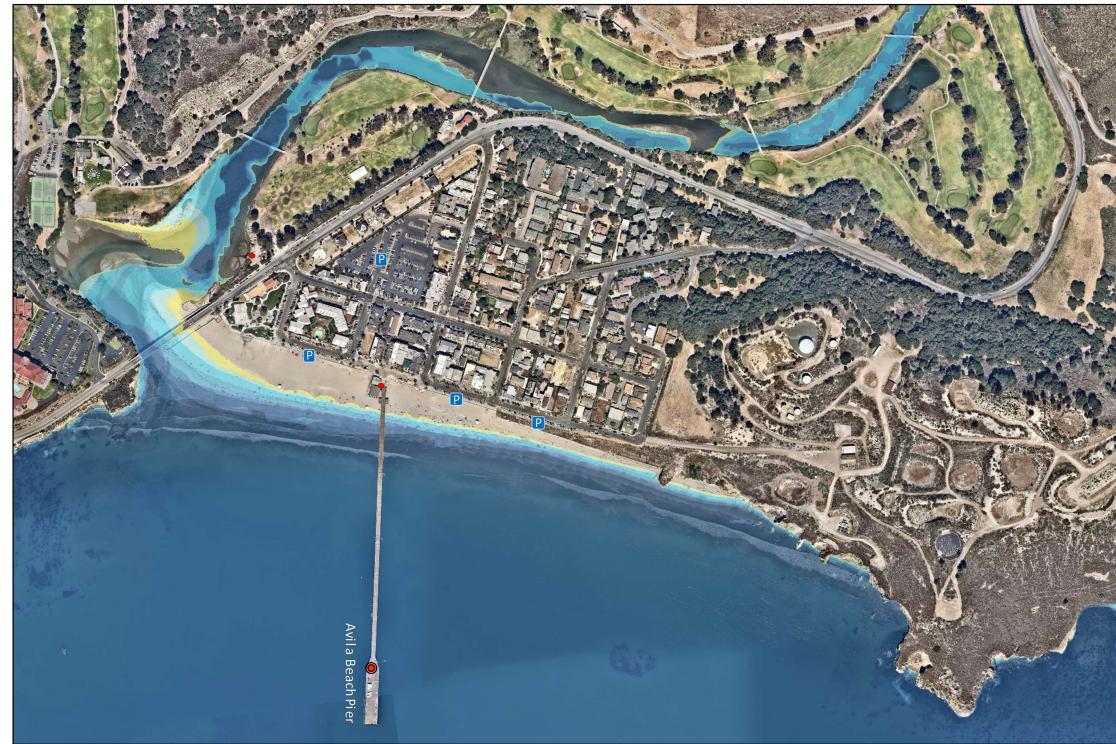
Plate 4: Flood Hazard Zones associated with Daily Inundation due to Rising Tides and SLR by 2050.

Avila Beach 2050 Daily Inundation Hazard Zones

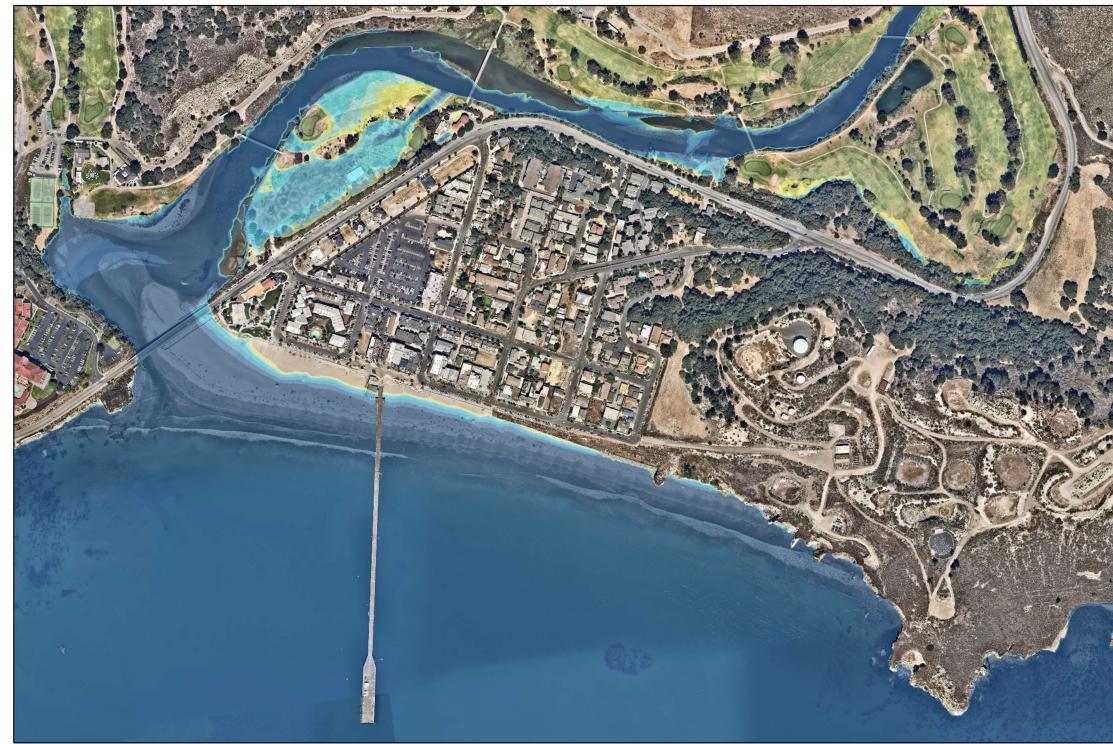
Plate 5: Flood Hazard Zones associated with Daily Inundation due to Rising Tides and SLR by 2100.

Avila Beach 2100 Daily Inundation Hazard Zones

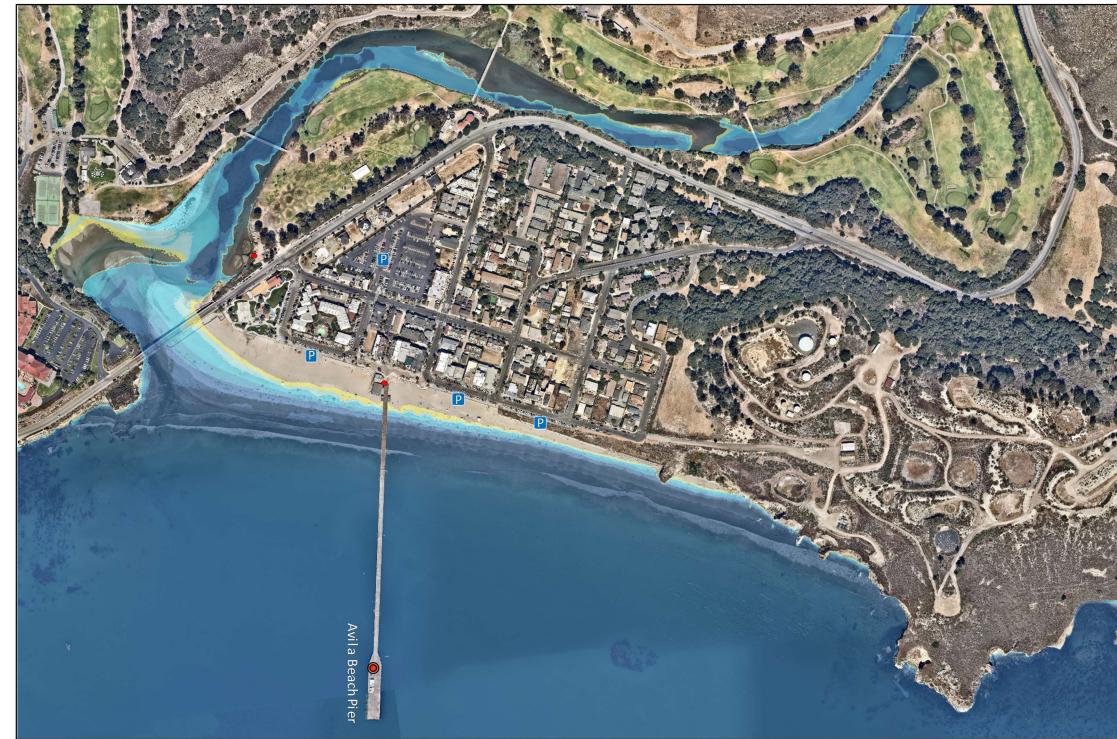
Plate 6: Flood Hazard Zones associated with King Tides for Existing Conditions.

Avila Beach Existing Conditions King Tides Hazard Zones
