Avila Beach

Sea-Level Rise Vulnerability Assessment

PORT SAN LUIS HARBOR DISTRICT AUGUST 2020

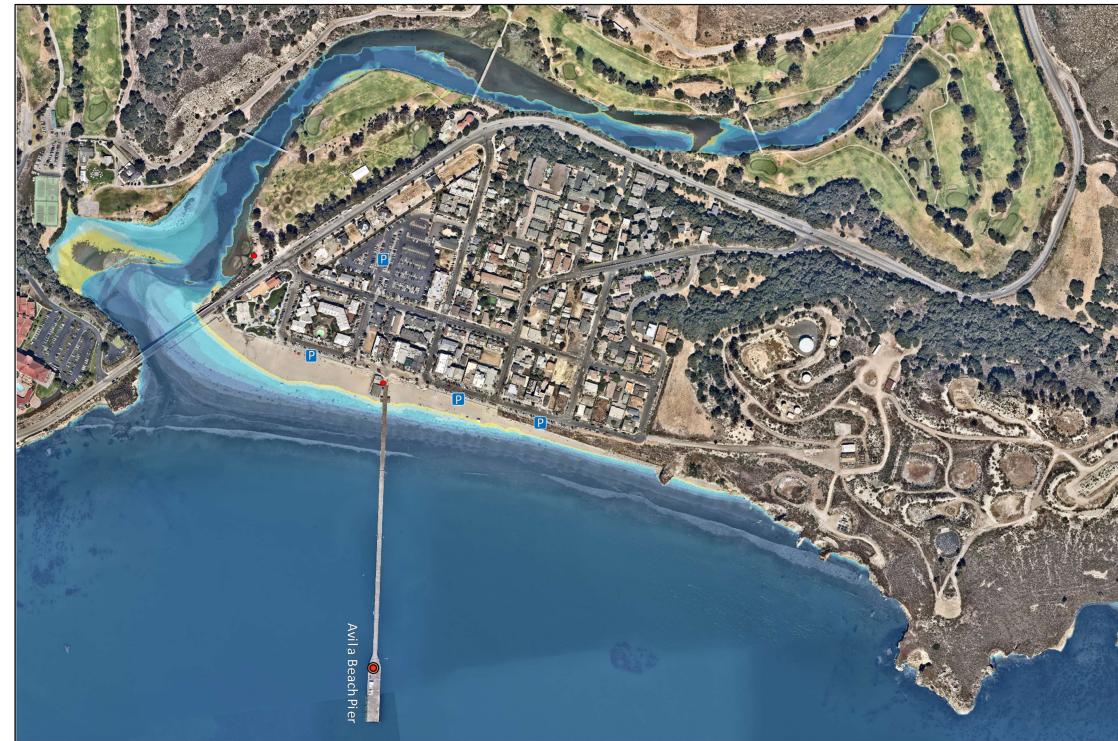
Plate 7: Flood Hazard Zones associated with King Tides and SLR by 2030.

Avila Beach 2030 King Tides Hazard Zones

- Harford Landing, Appendix B, Plate 6 to 9 (existing conditions, 2030, 2050, and 2100).
- Avila Beach Drive, Appendix C, Plate 6 to 9.
- Avila Beach, Appendix D, Plate 6 to 9.

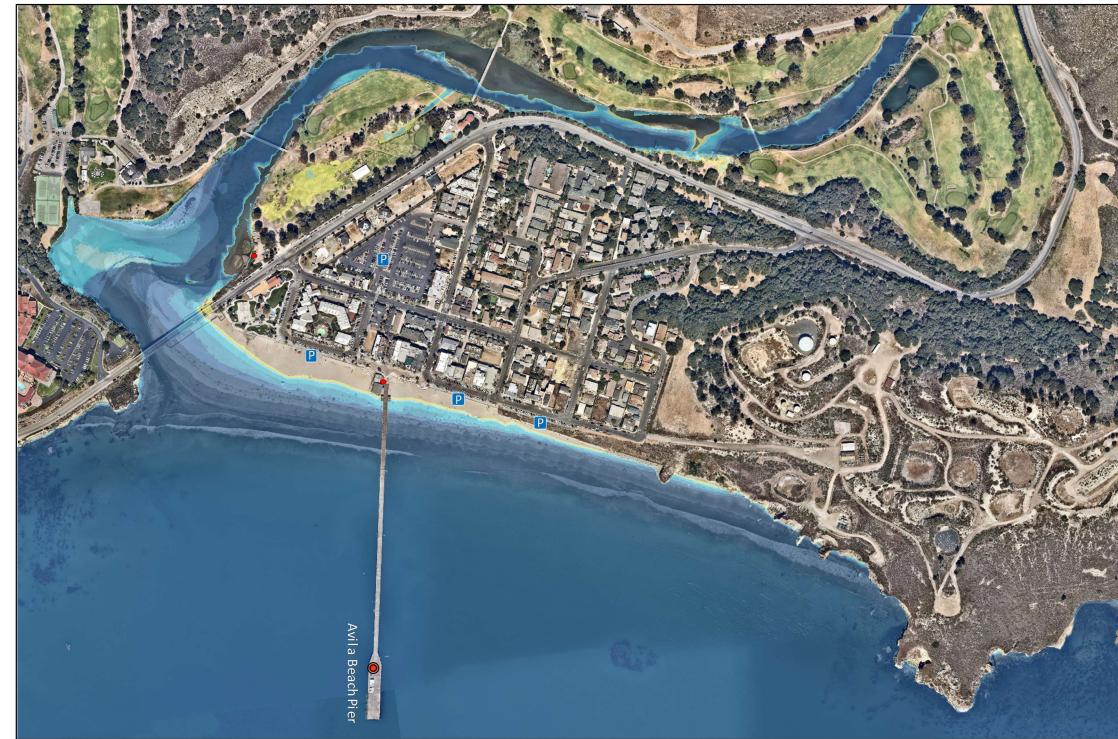
Plate 8: Flood Hazard Zones associated with King Tides and SLR by 2050.

Avila Beach 2050 King Tides Hazard Zones

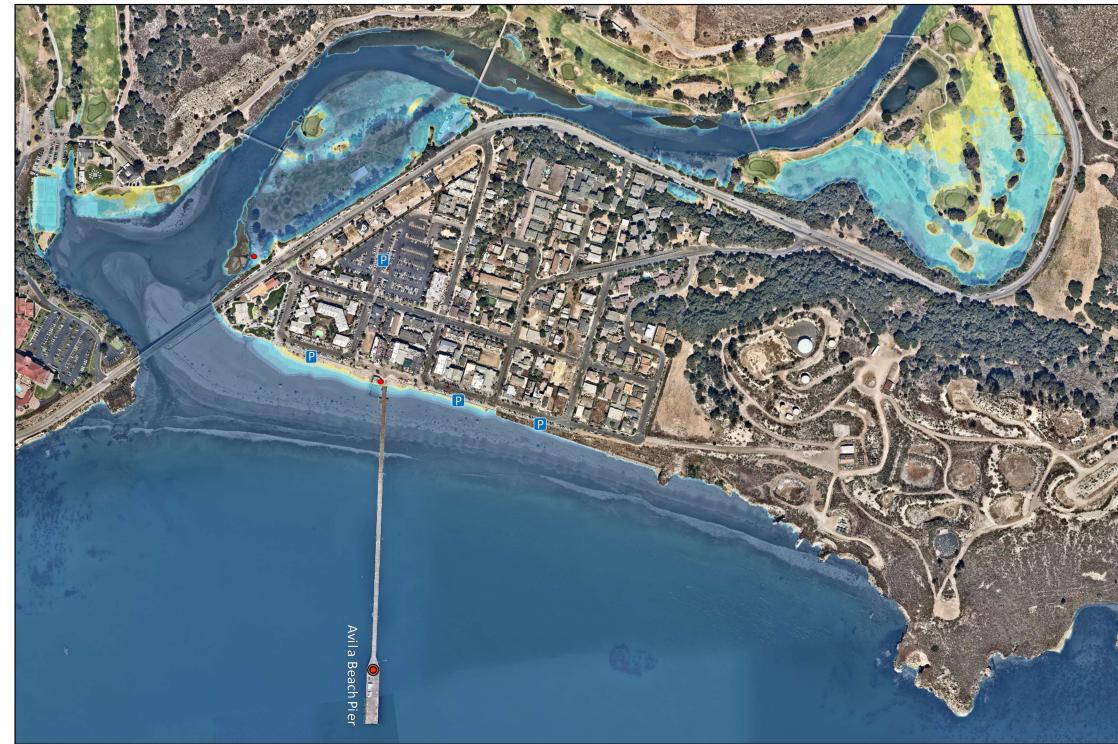
Plate 9: Flood Hazard Zones associated with King Tides and SLR by 2100.

Avila Beach 2100 King Tides Hazard Zones

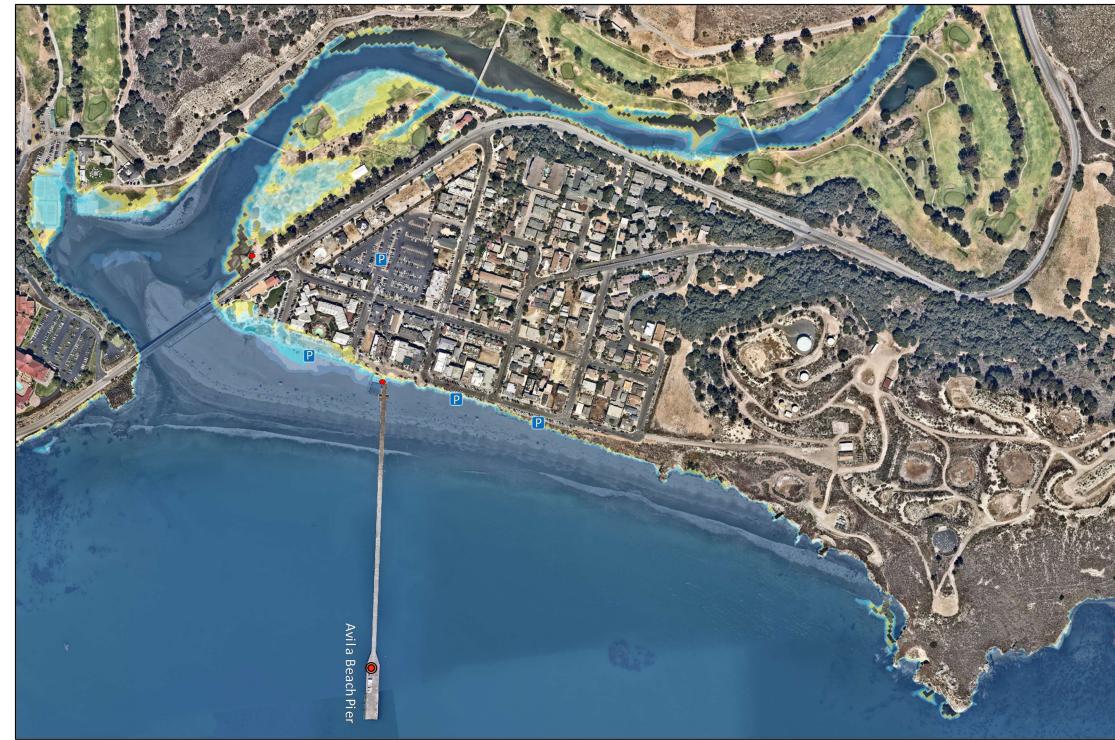
Plate 10: Flood Hazard Zones associated with a 100-Year Storm for Existing Conditions.

Avila Beach Existing Conditions 100-Year Storm Hazard Zones

- Harford Landing, Appendix B, Plate 10 to 13 (existing conditions, 2030, 2050, and 2100).
- Avila Beach Drive, Appendix C, Plate 10 to 13.
- Avila Beach, Appendix D, Plate 10 to 13.

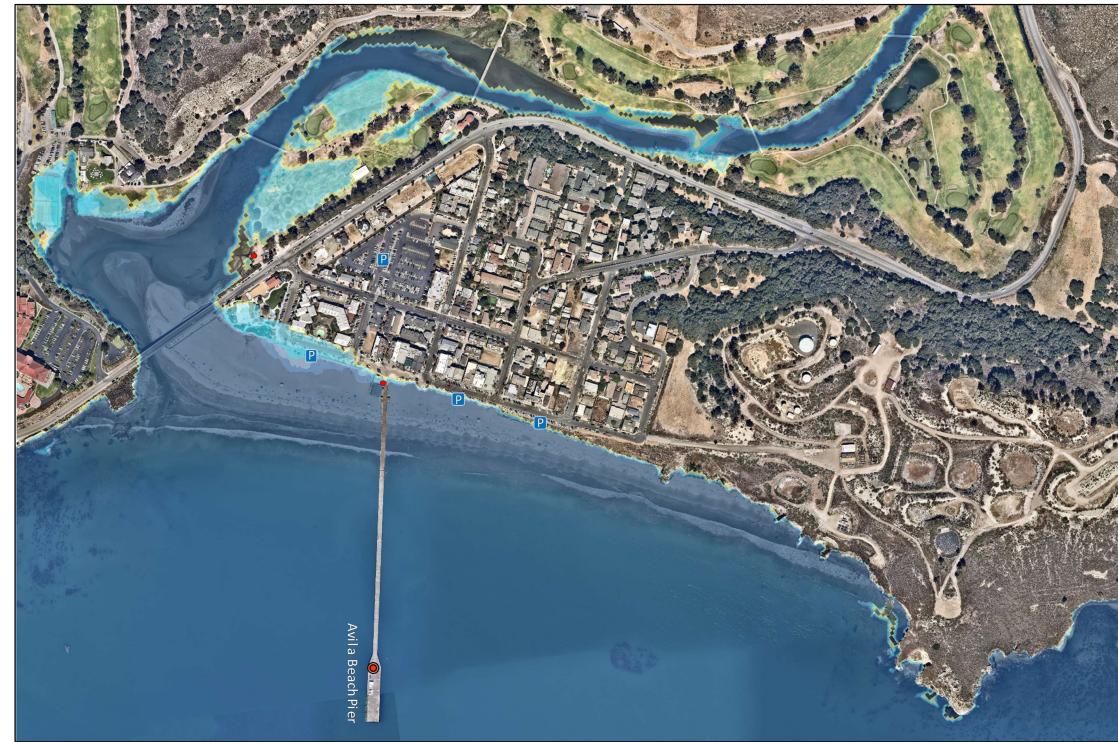
Plate 11: Flood Hazard Zones associated with a 100-Year Storm and SLR by 2030.

Avila Beach 2030 100-Year Storm Hazard Zones

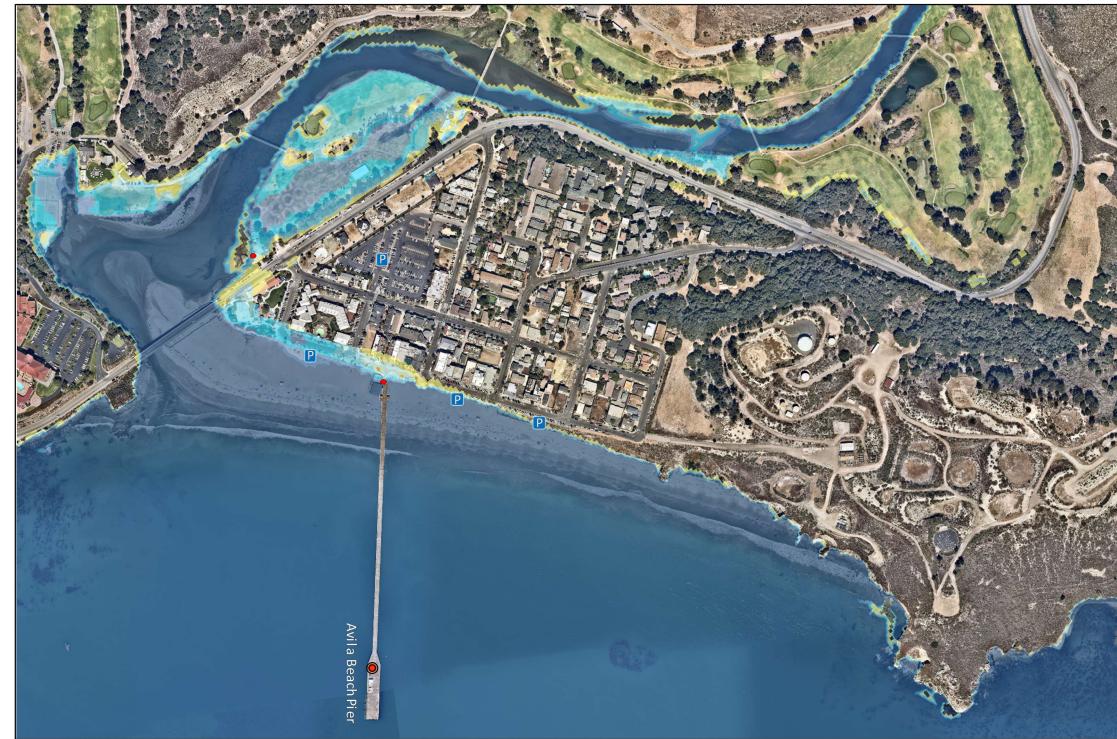
Plate 12: Flood Hazard Zones associated with a 100-Year Storm and SLR by 2050.

Avila Beach 2050 100-Year Storm Hazard Zones

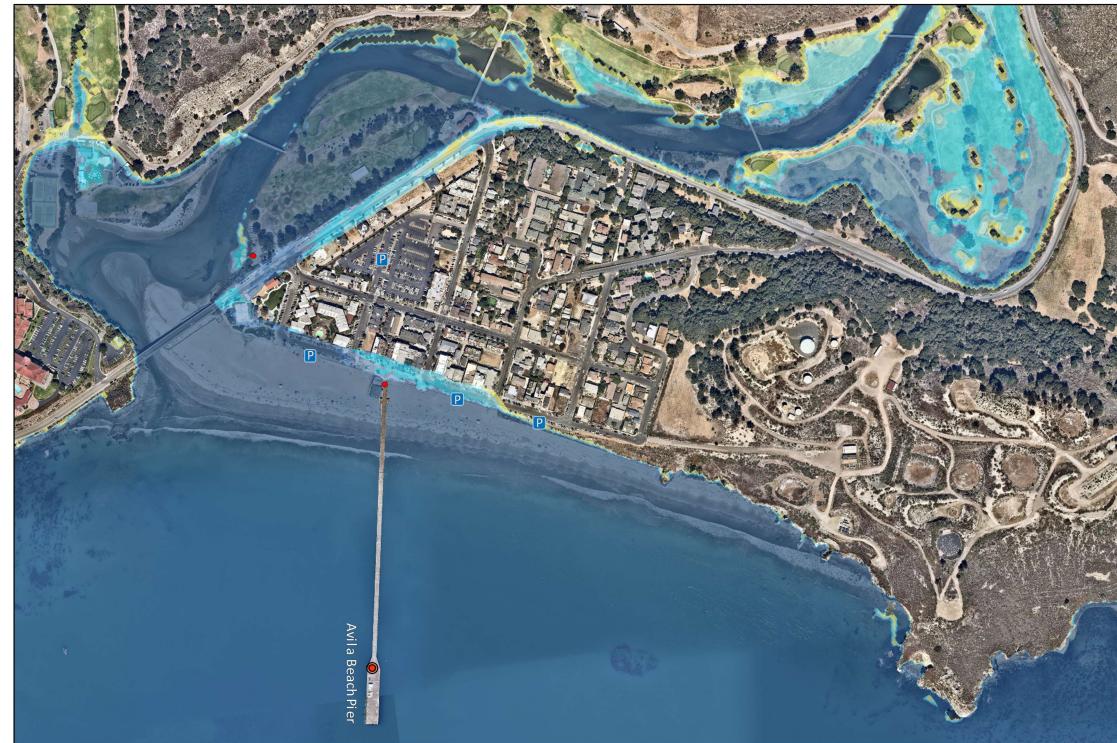
Plate 13: Flood Hazard Zones associated with a 100-Year Storm and SLR by 2100.

Avila Beach 2100 100-Year Storm Hazard Zones
