# Pillar Point Harbor

## Sea-Level Rise Vulnerability Assessment

PREPARED FOR SAN MATEO COUNTY HARBOR DISTRICT  
MAY 3, 2018

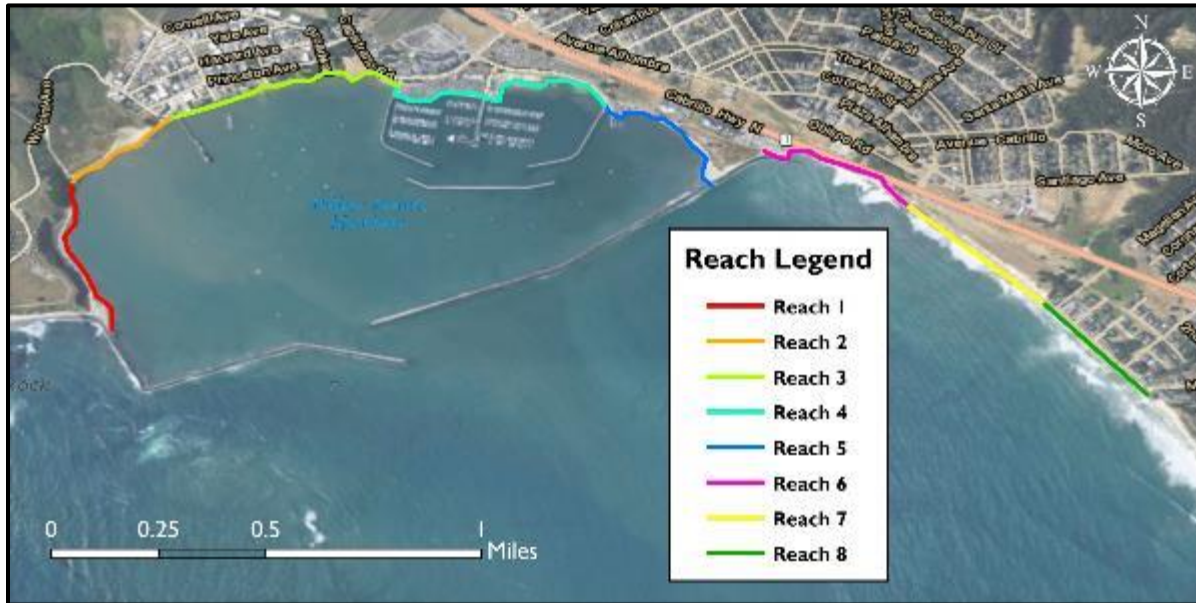
Figure 1: Study Area Reach Map

The purpose of this report is to present the findings from our assessment (study) of the vulnerabilities of Pillar Point Harbor (PPH) to the effects of sea level rise (SLR) in accordance with the requirements for Public Trust Lands (Per Assembly Bill AB-691). The figure below shows the study area, which is divided into eight reaches.

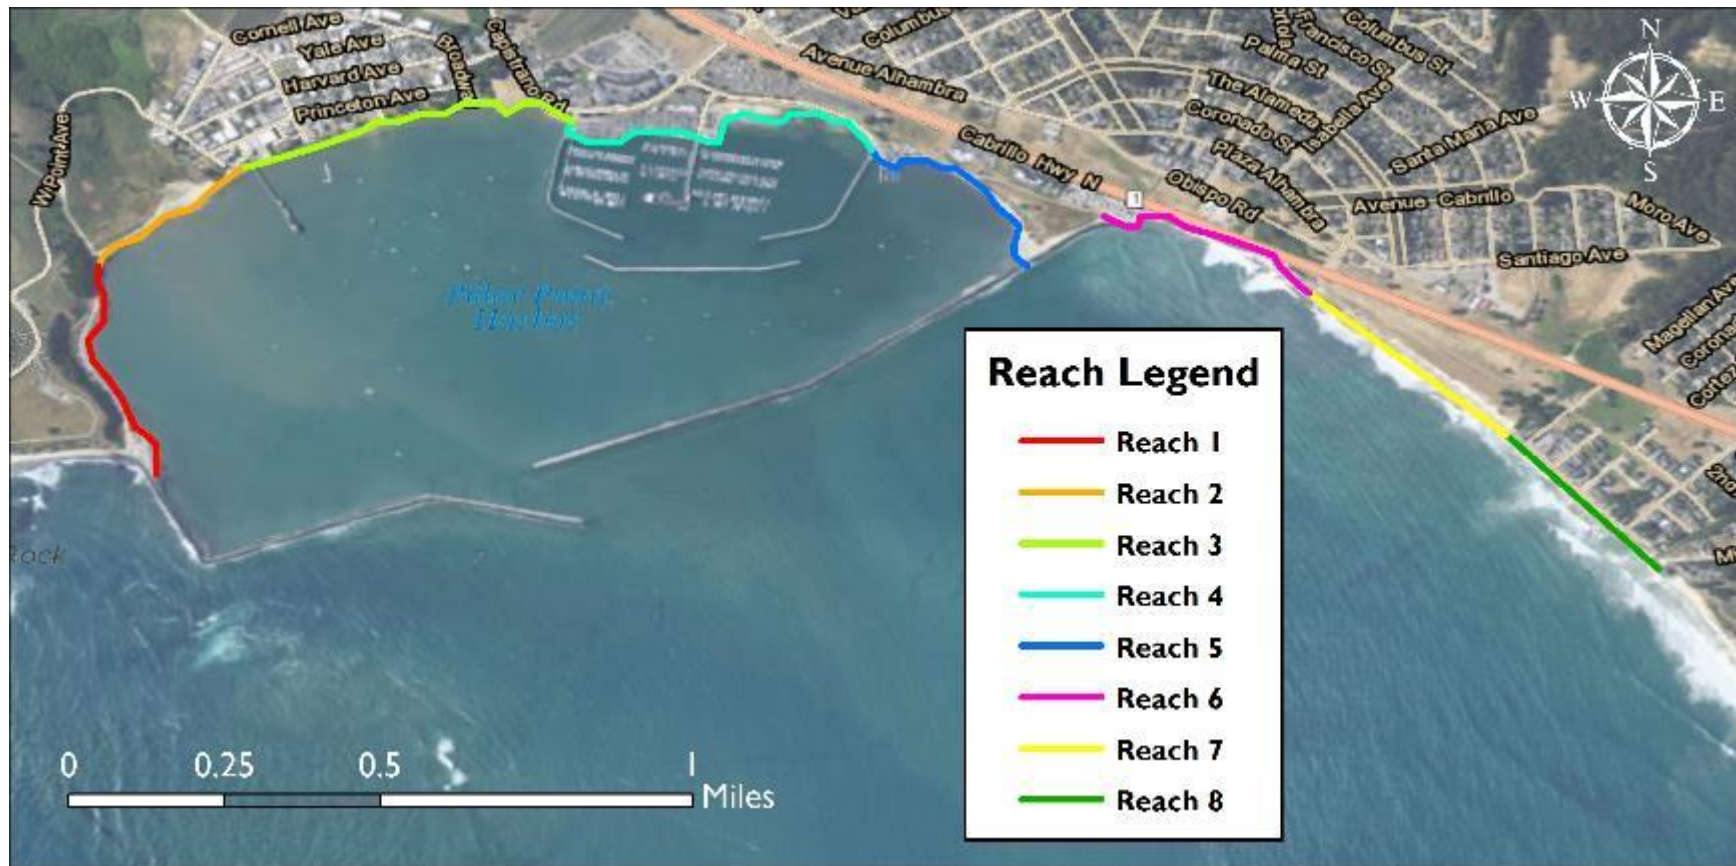
Figure 2-3: Reach Map

The study area is divided into eight reaches in this work, demonstrated in Figure 2-3.

In this section, a review of current shoreline conditions at Pillar Point Harbor (PPH) and its surrounding area is provided. In the following discussion, the reach definition demonstrated in Figure 2-3 is employed to explain shoreline conditions within the study area. Also, the California Coastal Record's pictures of the study area, which were taken in June 2013, are included in Appendix B for further clarification.

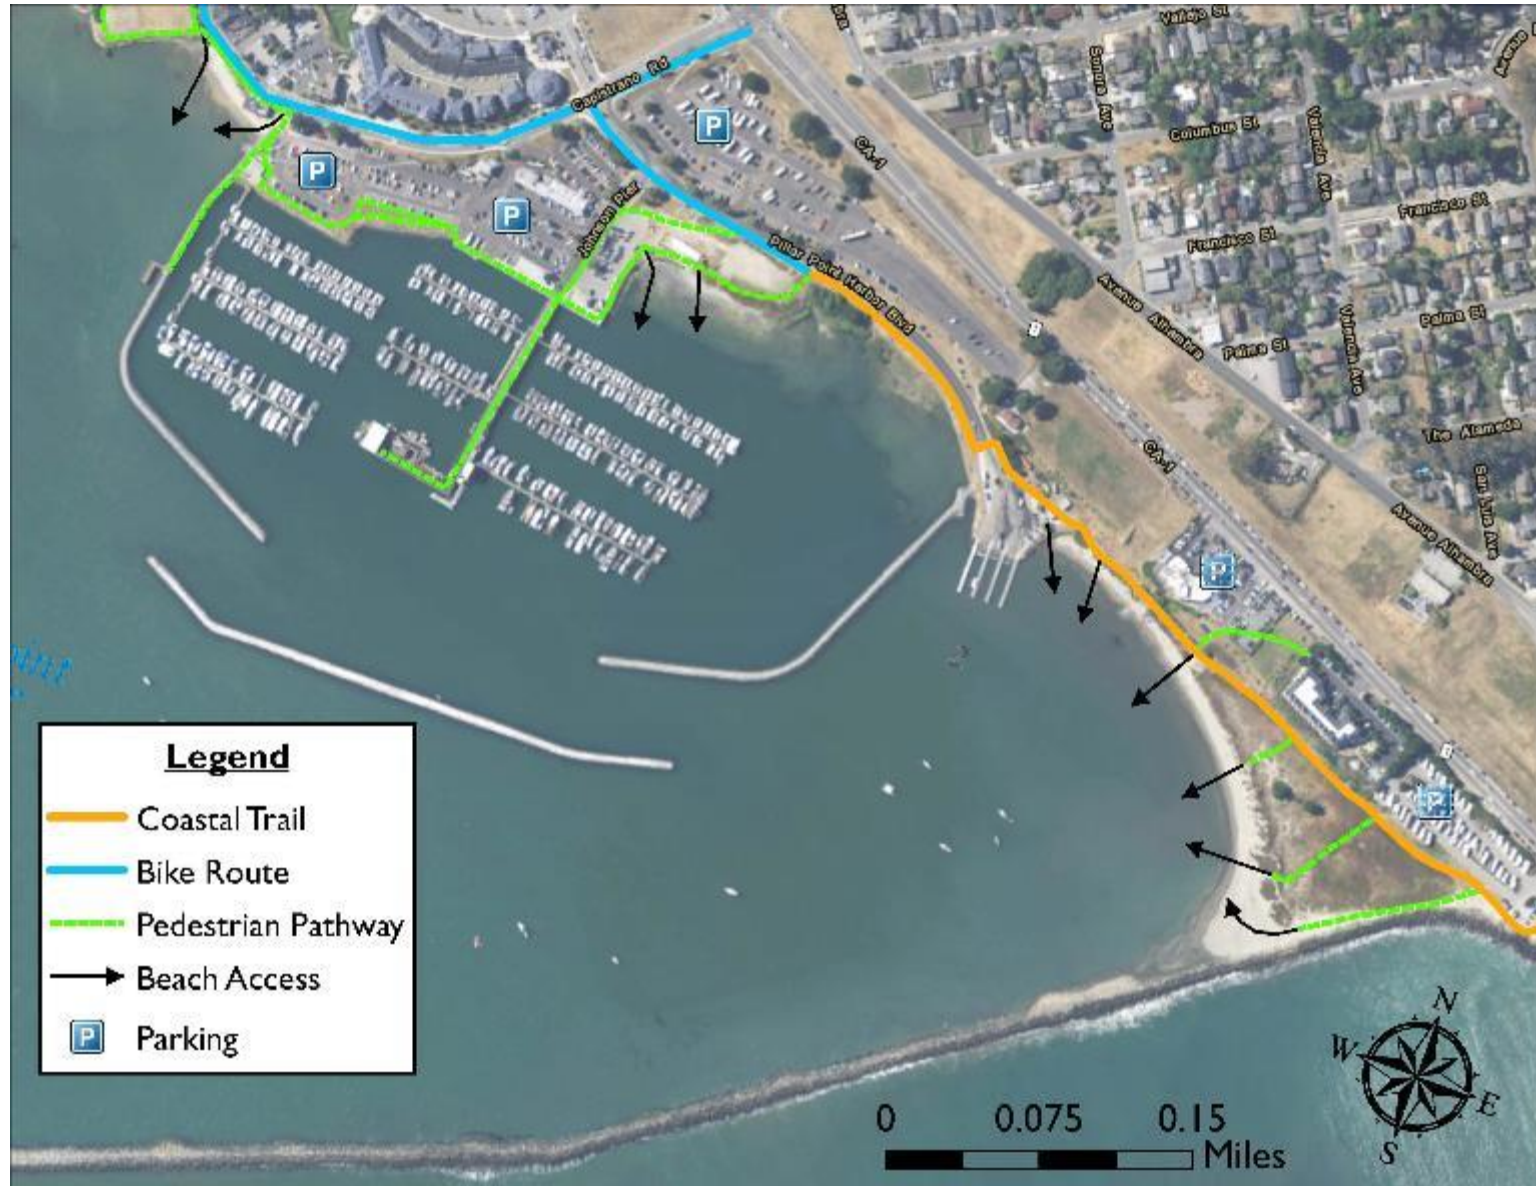
Figure 2-6: Public Access Map for Reaches 4 and 5

Figure 2-6 shows access routes to the beaches located on Reaches 4 and 5. The Johnson pier, PPH Beach, and a kayak launch are located in this area. The California Coastal Trail passes by the PPH Beach connecting Half Moon Bay to Princeton.

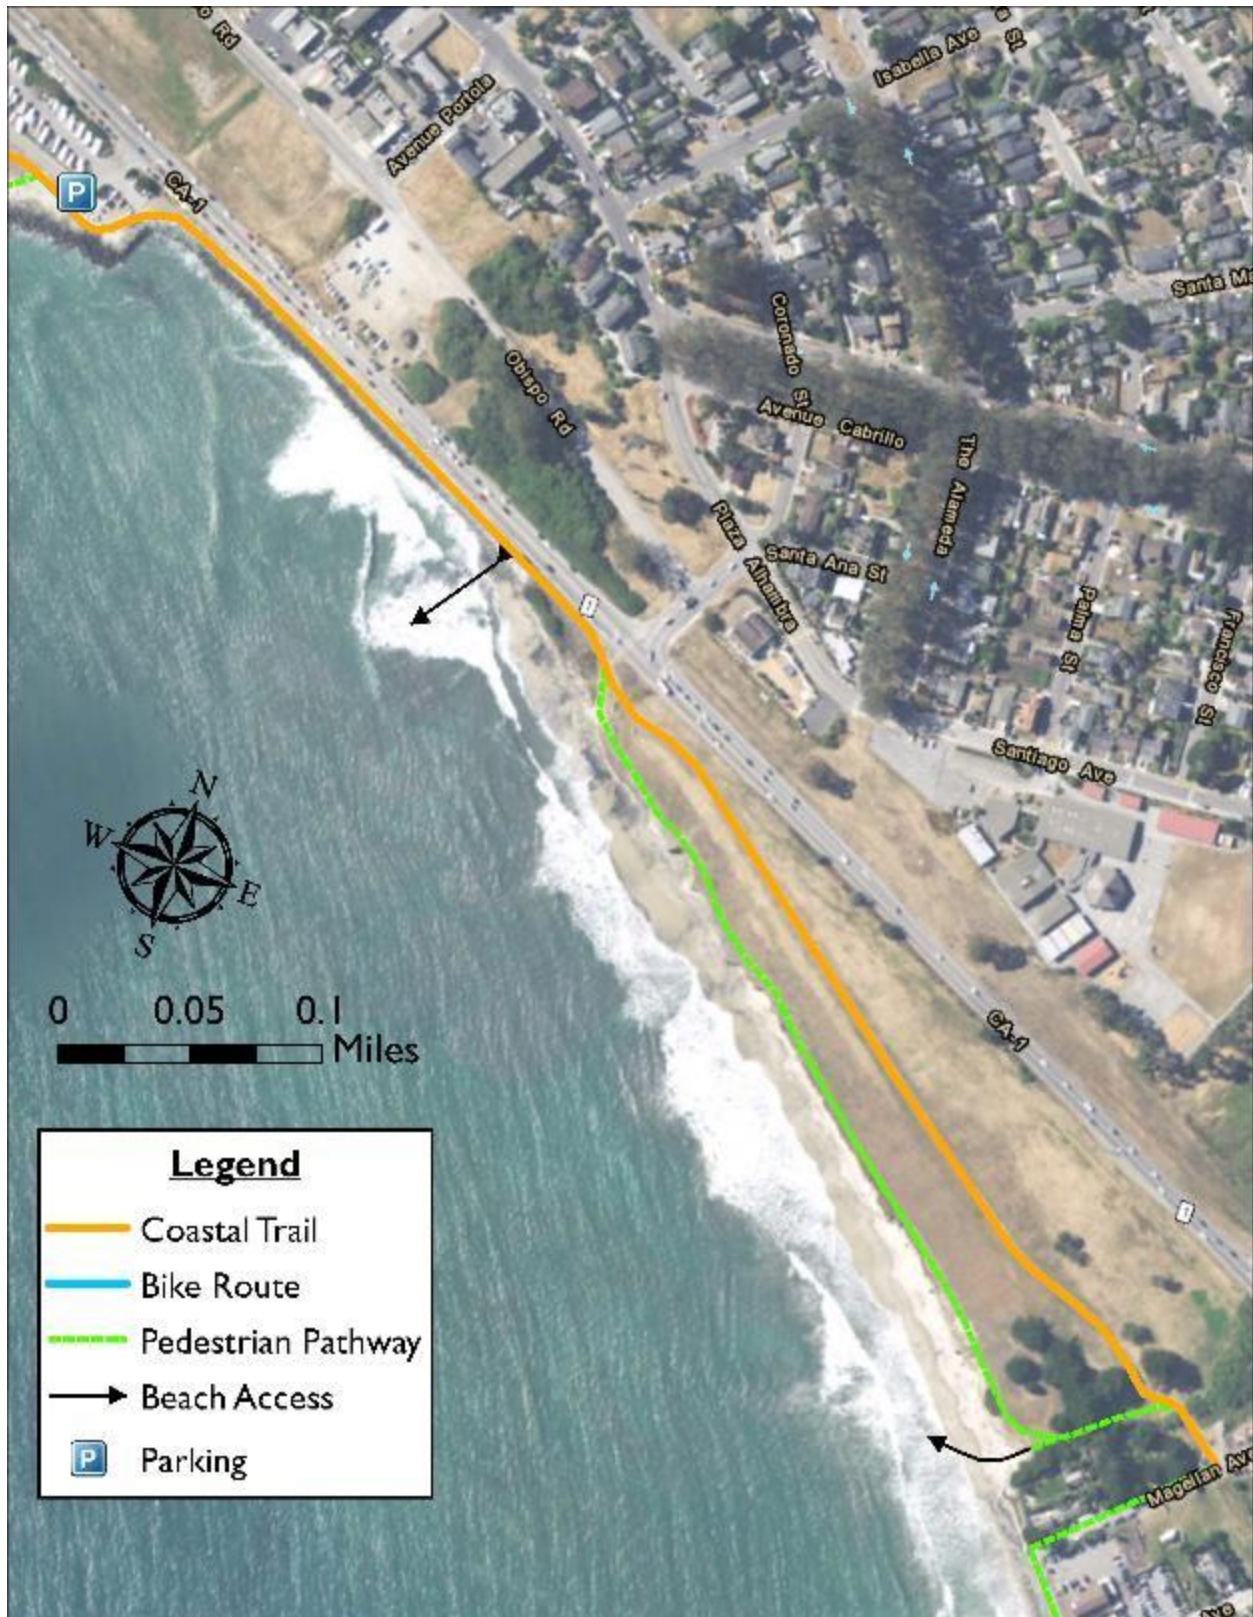
Figure 2-7: Public Access Map for Reaches 6, 7 and 8

Figure 2-7 shows beach access routes and the coastal trail in the vicinity of Surfer's Beach and Vallejo Beach (Miranda Beach) located on Reaches 6, 7 and 8. At high tide, the waves crash right on the rocks that protect the highway from erosion, making Surfer's Beach inaccessible. However, during the low tide enough sand is exposed for public access. Moreover, Vallejo Beach and Miramar Beach are located on Reaches 7 and 8, in the north of Half Moon Bay community of Miramar. These beaches are accessible from the south through Miramar, and from the north through a staircase located next to the coastal trail.

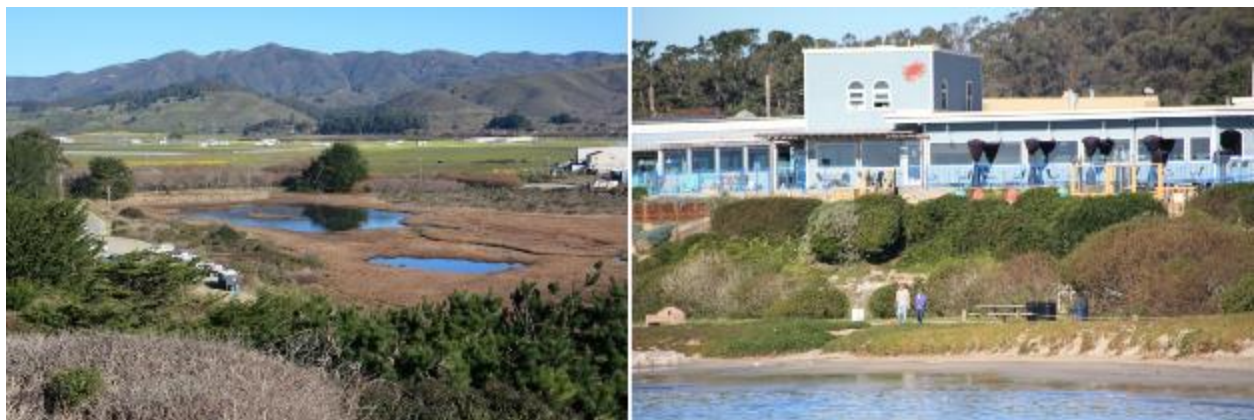
**Figure 2-8: Pillar Point Marsh Wetland (Left) and Pillar Point Harbor Beach Coastal Strand**

Based on the *USACE (2015)* work, a brief review of PPH biological habitat is provided here. There are two protected coastal habitats located within the study area (Figure 2-8). Pillar Point Marsh Wetland (Figure 2-2) is a protected area for the salt marsh habitat in PPH. A sandy beach is located at the mouth of the creek that drains from the wetland. Moreover, a coastal strand is located in a fenced off area at the sandy back beach of the PPH Beach (Figure 2-2) near the base of the East Breakwater.

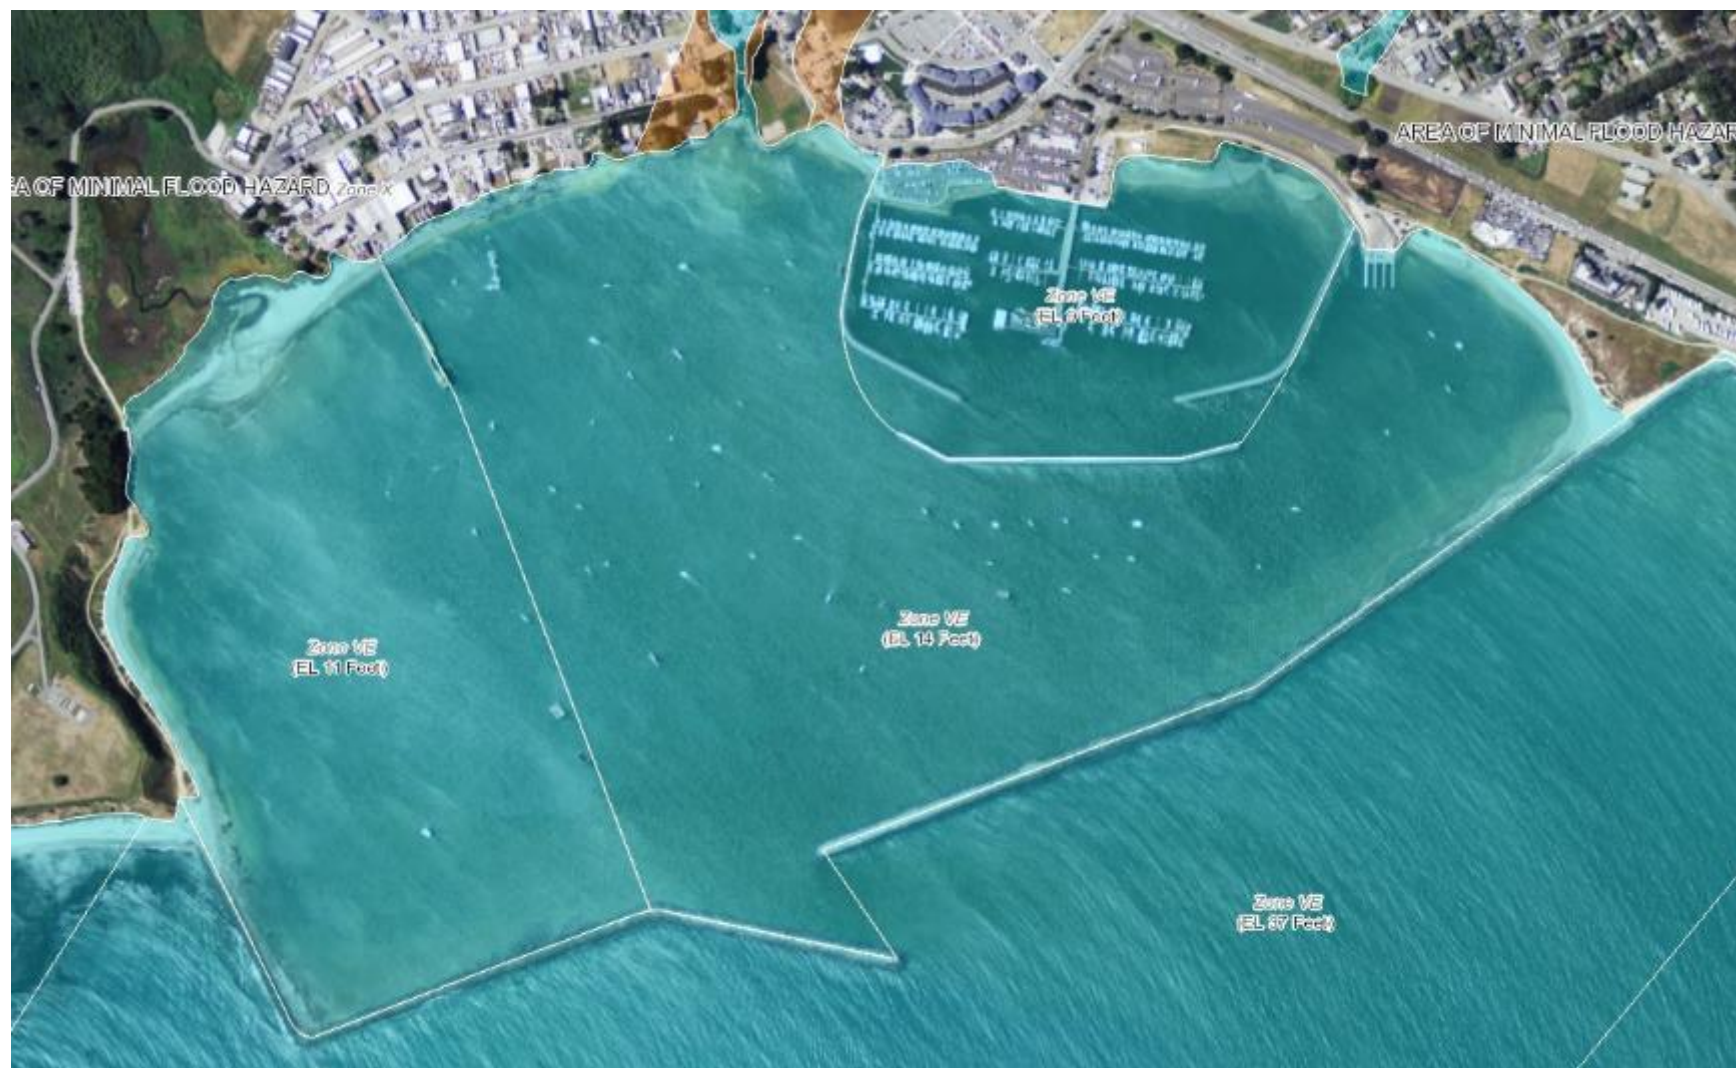
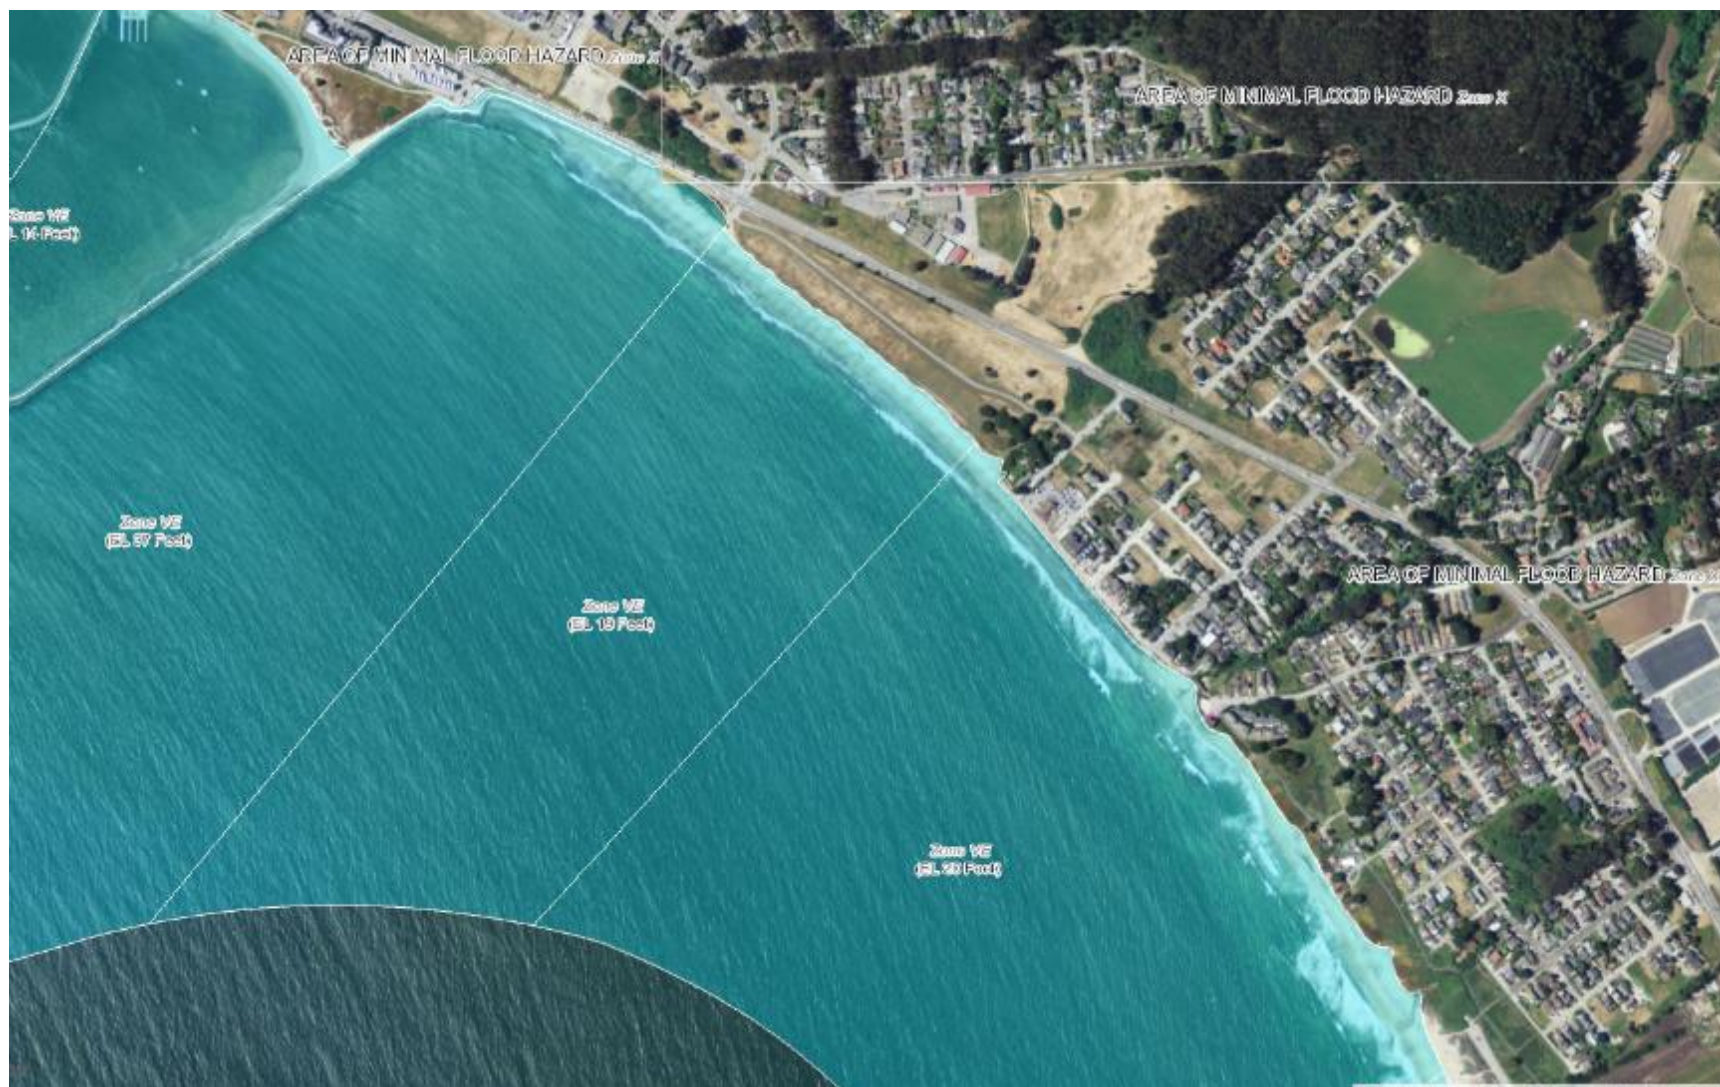
Figure 2-15 and Figure 2-16 show the FEMA 100-year flood zones for the project area. The areas indicated by orange color illustrate the 500-year flood zones. Based on the FEMA flood maps, beach access will be limited during the 100-year storm condition for almost all of the reaches within the study area.

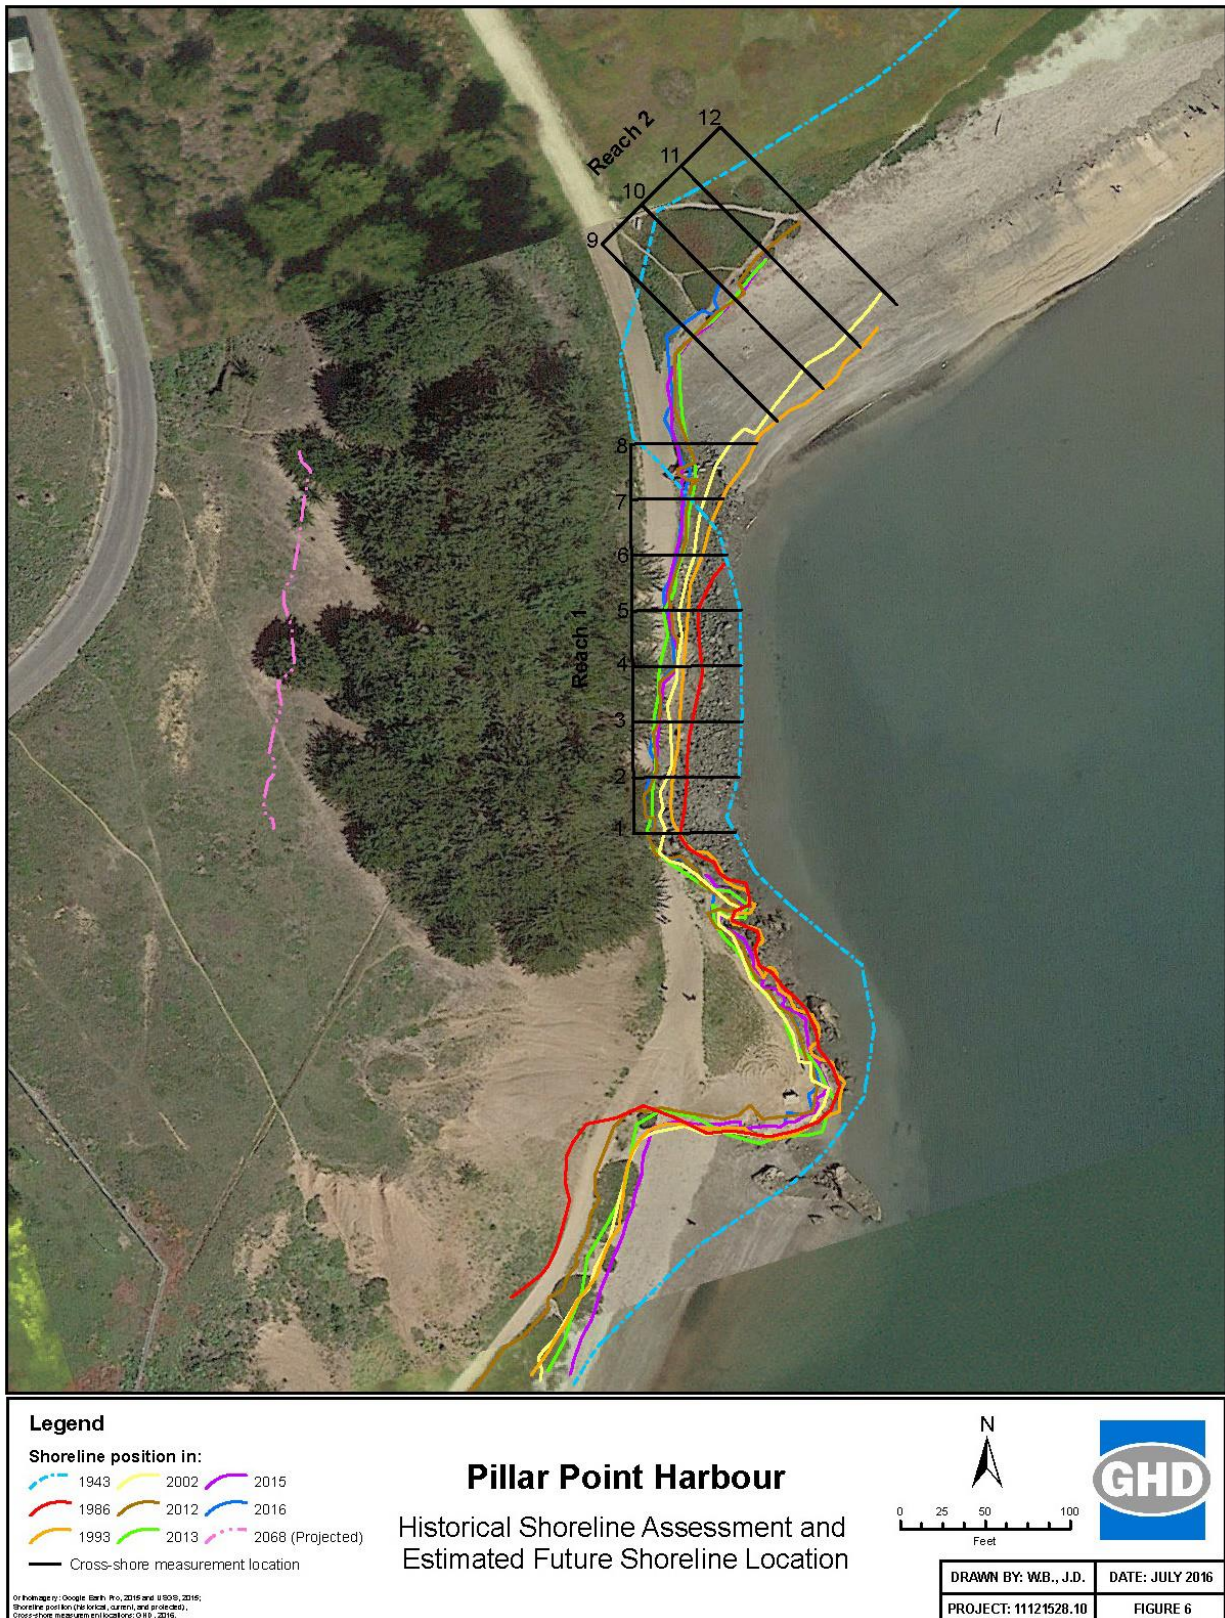
**Figure 2-19: Shoreline Changes near the Mavericks Coastal Trail**  
Picture Taken from GHD (2016)

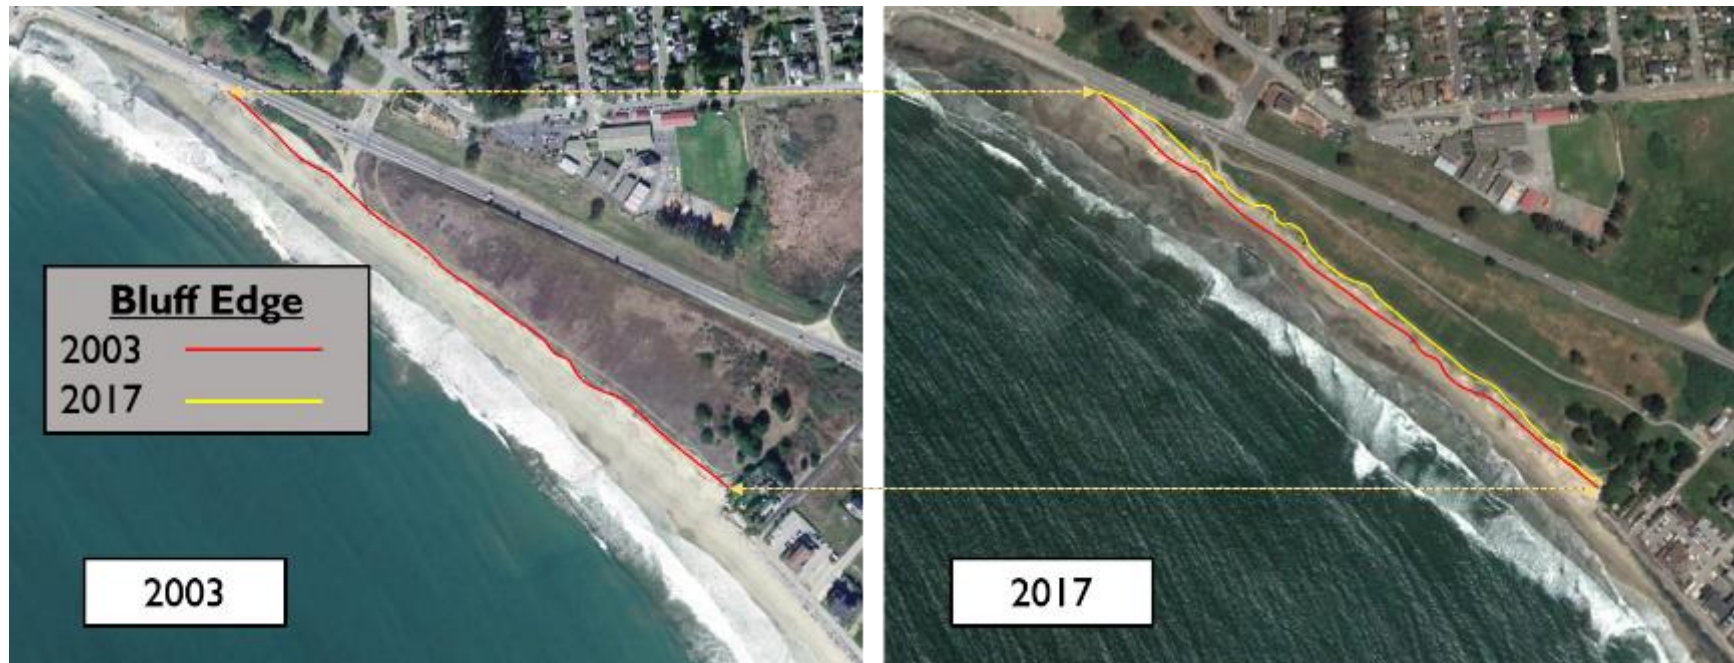
Figure 2-20: Bluff Recession on Reaches 6 and 7 from 2003 to 2017

Reach 7 consists of a wide beach with moderately fine sand, backed by a bluff about 10 feet high (Figure B-9 and Figure B-10). The bluff has been retreating over the past decades, which has caused damage to the old coastal trail (Figure 2-20).

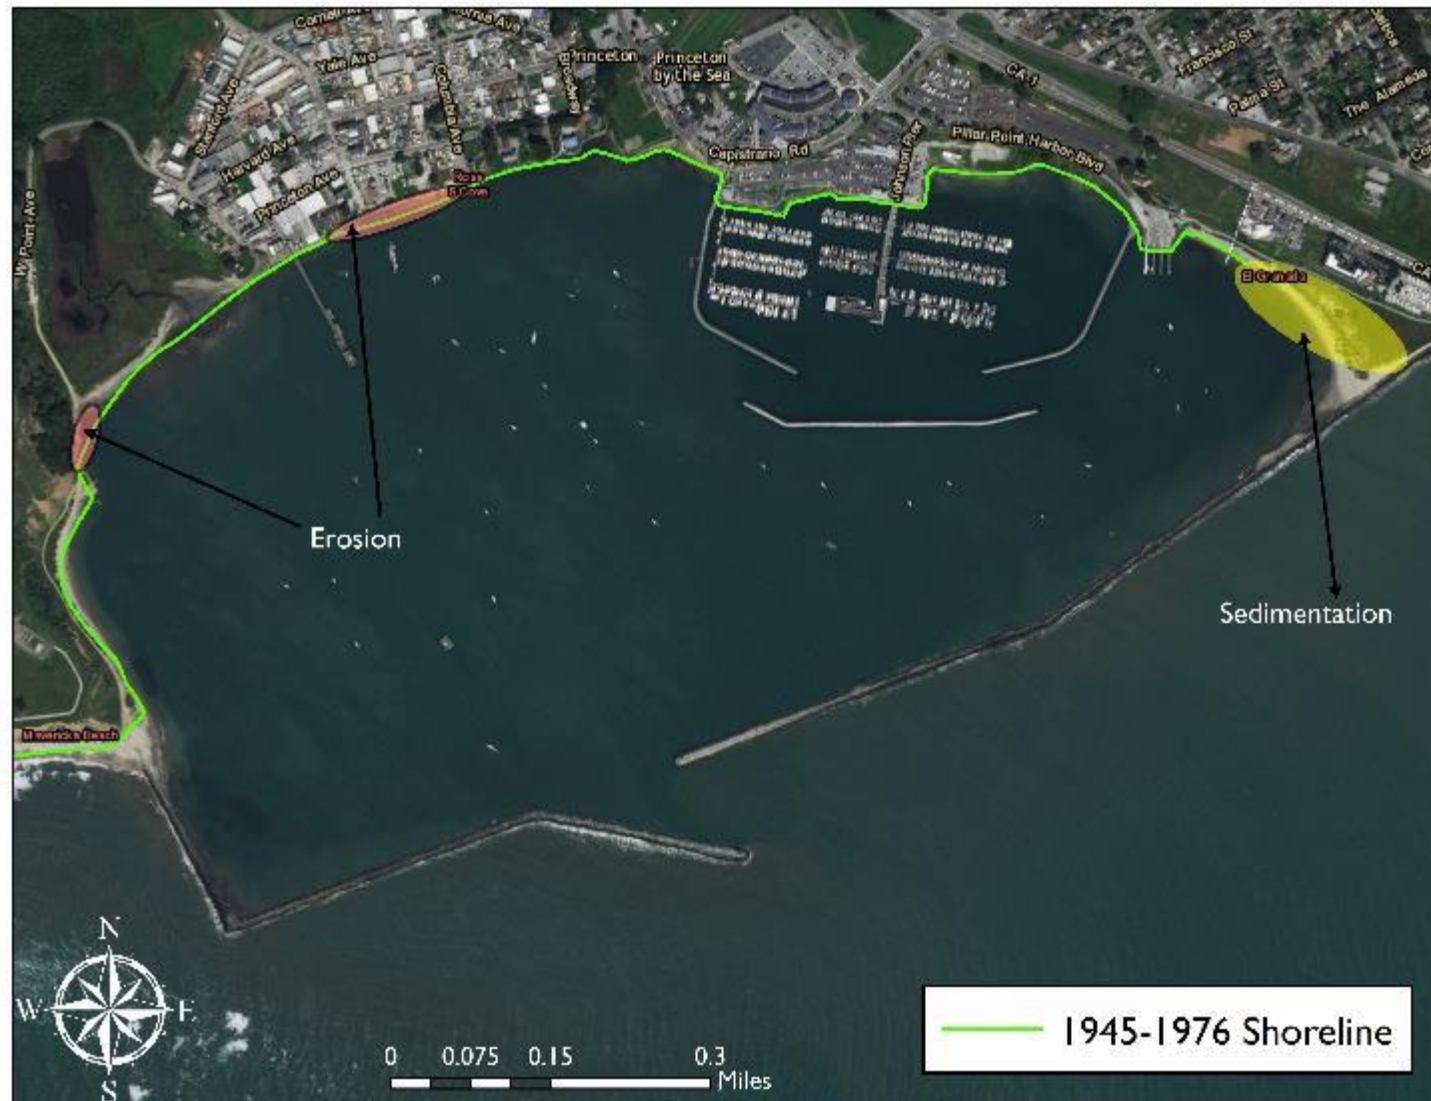
Figure 3-6: Shorelines Condition for Reaches 1-5

Figure 3-6 shows the shoreline changes for Reaches 1 to 5 which are located inside the harbor. The green line shown in this picture depicts the shoreline location between 1945 and 1976 measured by USGS. The comparison between the current shoreline and the USGS data shows that the shorelines inside the harbor are generally stable except for a few locations. The Princeton Beach is being actively eroded and will disappear in the future without a beach nourishment plan. Also, the area to the west of PPH Marsh beach will face erosion, where the berm would probably disappear in that particular spot (Figure 2-19), due to the presence of revetment and lack of sediment input. Moreover, the PPH Beach will keep accumulating sand as expected due to processes discussed in Section 2.8.

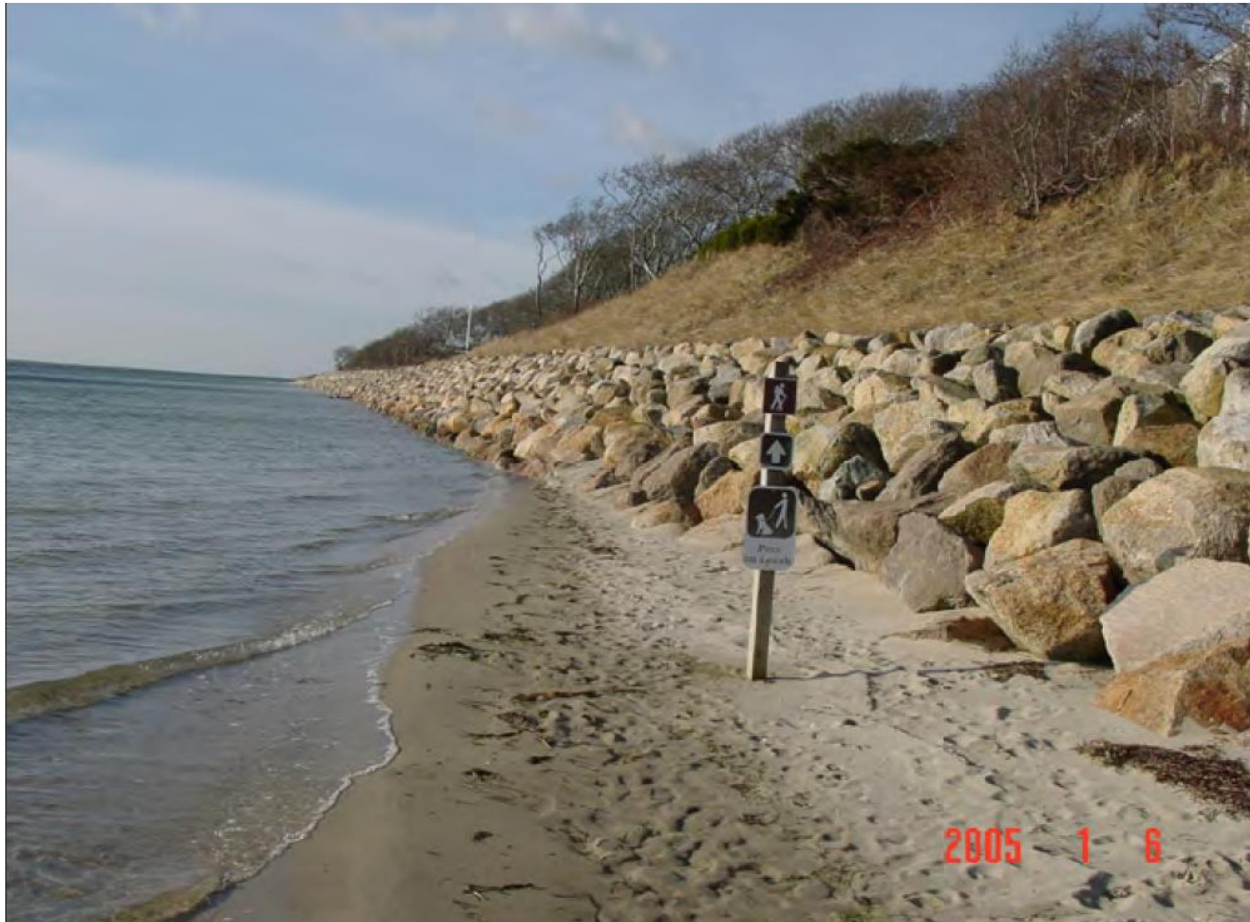
**Figure 5-1: Loss of Beach Access Due to Revetments**

In California, seawalls, revetments, and jetties are the primary hard solutions to manage shorelines. Seawalls are vertical structures that protect inland areas against wave action. Revetments are sloped structures consisting of rock to dampen the wave energy and prevent shoreline retreat. In contrast to beach nourishment, hard solutions are considered to be long-term or even permanent to stabilize the shoreline and prevent inland flooding. However, several negative consequences are associated with revetments and seawalls. Since the hard structures fix the shoreline location, there will not be any room for retreat during future higher water levels, which results in loss of the beach in front of them (Figure 5-1). The erosion problem at Surfer's Beach (Reach 6) is an example of this negative effect of revetments. Also, hard structures are not known to be environmentally friendly, with several reports that coastal armoring reduced the diversity and abundance of coastal habitats (*CDBW, 2011*).
